**On the Attack
Against ROK Ship
Cheonan**

Ministry of National Defense
Republic of Korea

September 2010

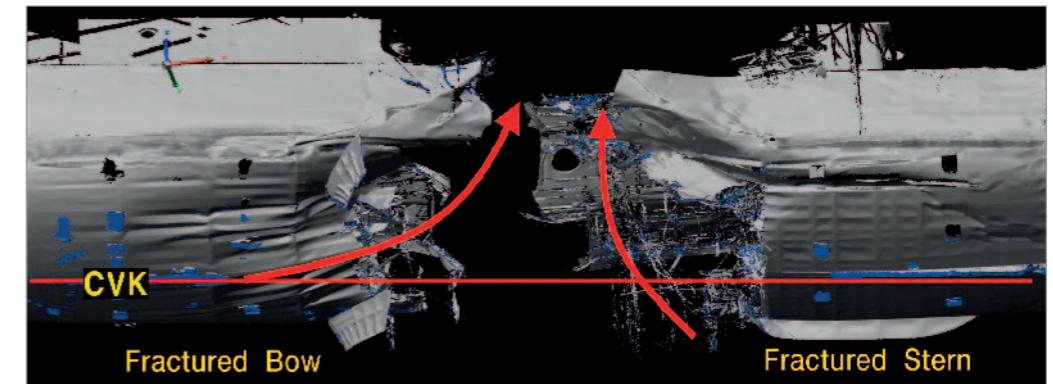
<Figure Summary-1> 3D laser scan image of the fractured bow and stern

As seen in <Figure Summary-1>, the upward bending of the bottom of the stern and bow indicates that an underwater explosion took place.

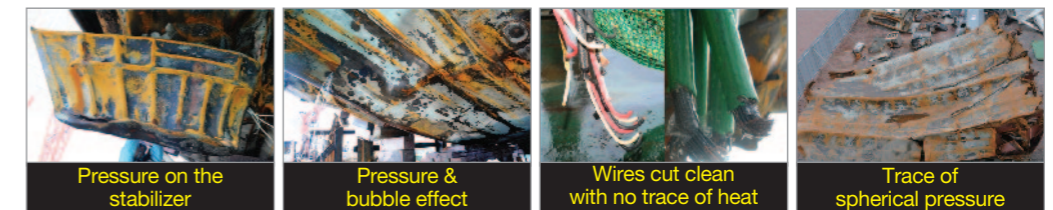
<Figure Summary-2> Traces of shockwave and bubble effect

Second, as seen in <Figure Summary-2>, through a thorough investigation of the interior and exterior of the ship, the JIG had found evidence of extreme pressure on the fin stabilizer, which prevents significant rolling of the ship; traces of high water pressure and bubble effect on the hull bottom; wires cut with no traces of heat; and traces of spherical pressure on the gas turbine room. The above indicate that strong shockwave and bubble effects caused the splitting and sinking of the ship.

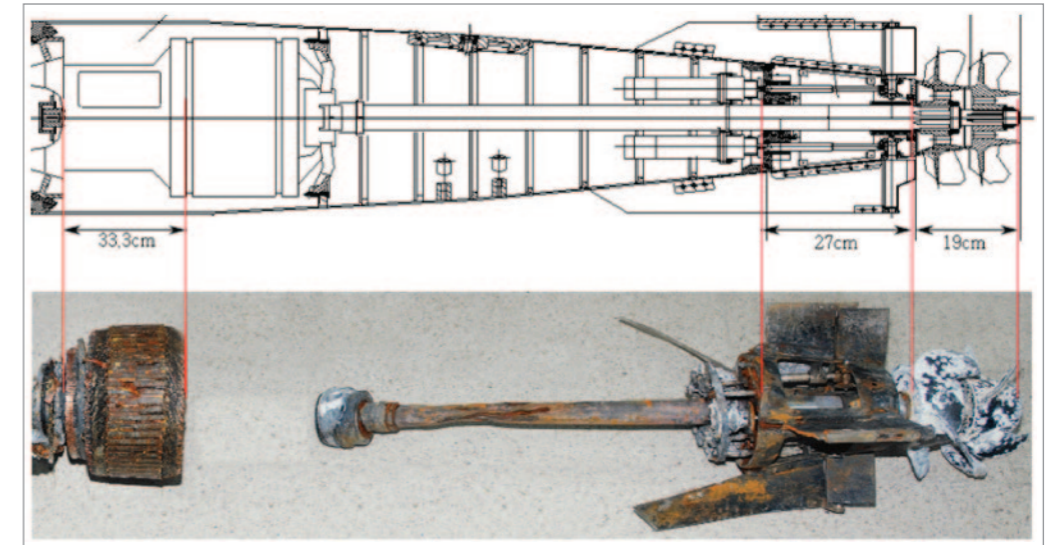
<Figure Summary-3> Schematic of torpedo and recovered rear section of torpedo

Lastly, on May 15, the JIG recovered the conclusive evidence that confirmed the use of a torpedo during a detailed search in the vicinity of the incident location using special nets. The conclusive evidence was a torpedo propulsion motor system including propellers, a propulsion motor, and steering section. The evidence is consistent with the drawing shown in <Figure Summary-3> in its size and design. The figure was a part of an introductory brochure produced by **North Korea** for an export purpose.

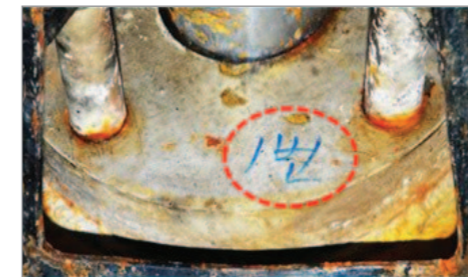
<Figure Summary-4> Rear section of torpedo

As shown on <Figure Summary-4> and <Figure Summary-5>, the Korean marking “1번(No. 1 in English)” inside the rear section of the propulsion system is similar to the marking of a **North Korean** test torpedo obtained in 2003.

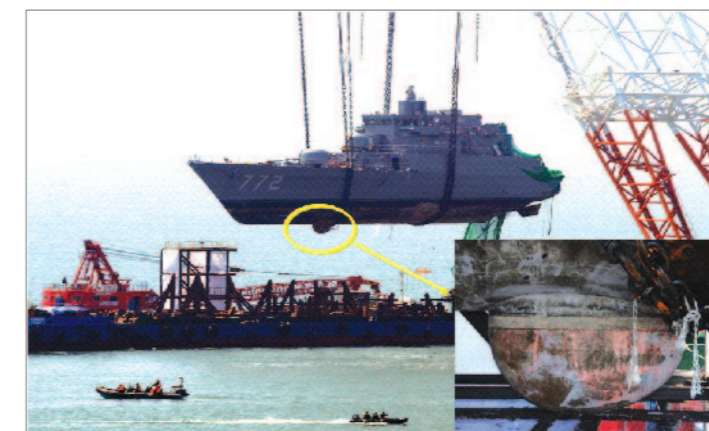
<Figure II-1-1> The sonar dome at the time of bow salvage

No scratch or cutting consistent with a grounding was found on ROKS Cheonan on the bottom of the hull along the longitudinal direction. In addition, the sonar dome, and propellers located on the very bottom of the ship, were observed with no grounding damages as displayed in <Figure II-1-1> and <Figure II-1-2>. Furthermore, two types of hull deformations, impossible to occur in a grounding event, were observed.

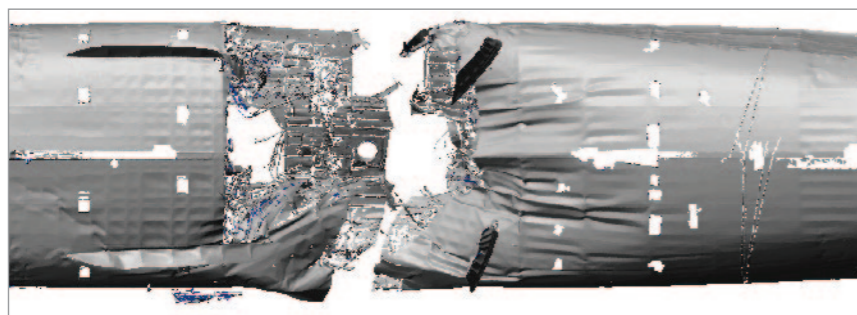
〈Figure II-1-3〉 Dishing on the shell plating panels on the bottom of the hull

(See 〈Figure II-1-3〉). This is a result of extreme pressure impacting broadly on the shell plates due to shockwave and bubble effect, and cannot be explained with grounding as a cause.

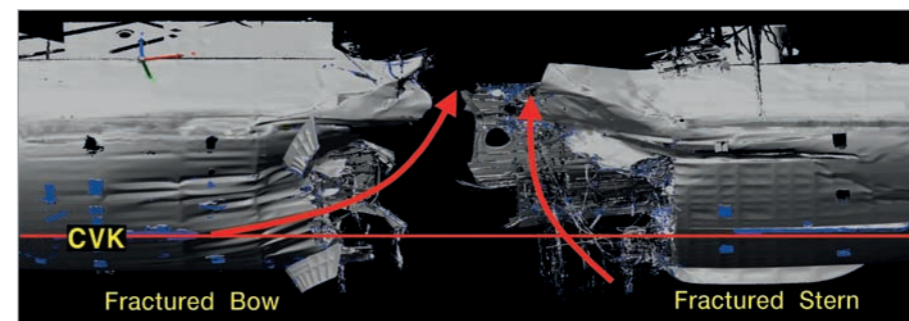
〈Figure II-1-4〉 3D laser scanning images on breakplanes of bow and stern

Secondly, shell plates on the bottom of the fractured area bent significantly inward. On the stern side of the fractured areas, shell plates were deformed in an upward direction, from the bottom of the hull to the main deck level(See 〈Figure II-1-4〉). The shell plates on the bow portside of the fractured areas also suffered an equivalent level of inward deformation. The shell plates on the portside of the bow were deformed in concave curvature with the

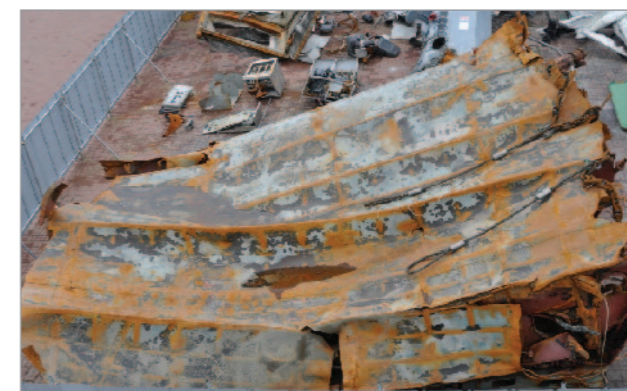
〈Figure II-1-5〉 Shell plates of ROKS Cheonan gas turbine room

center located outside of the ship. The CVK below the gas turbine room, as shown in 〈Figure II-1-5〉, had also been severely deformed in an arc-shape by spherical pressure. These cannot occur in case of a grounding.

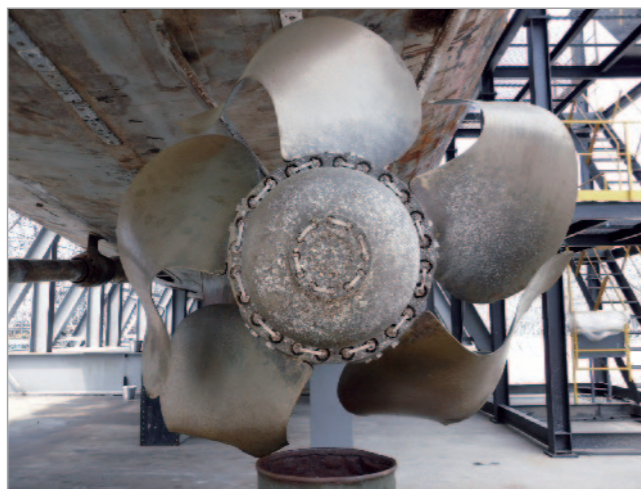
〈Figure II-1-7〉 The deformation of starboard propellers

the break of the blades or global scratch marks were absent, which would have occurred in case of grounding, but no such traces were found. Instead, 5 blades were bent toward the bow side in a symmetric manner(See 〈Figure II-1-7〉). The Swedish Investigation Team assessed that this type of deformation cannot occur due to a grounding event, and concluded the possible cause as the mass force of inertia, which was created from the sudden halt of the propeller rotation, and propulsion shaft being pushed severely.

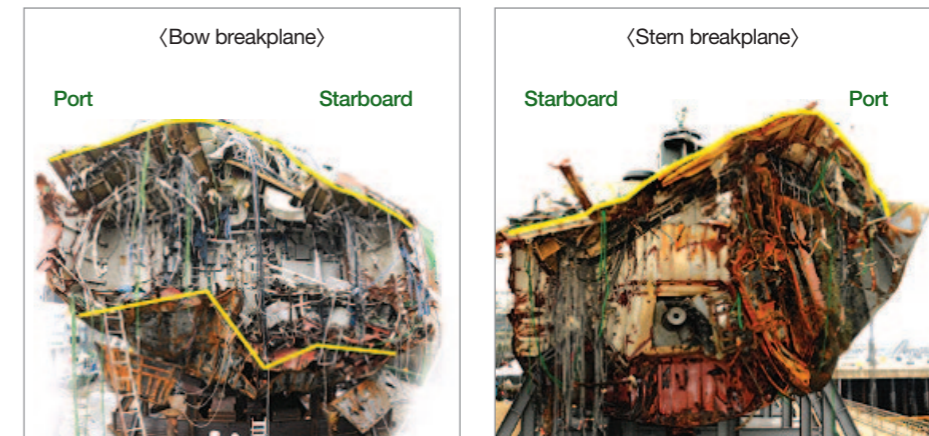
<Figure II-1-10> Breakplane of the bow and stern

A close inspection on the breakplane of ROKS Cheonan reveals that the bottom of the bow was bent upward, while the stern portside bottom was deformed extremely upward to the main deck level, to the point that it is almost not recognizable(See <Figure II-1-10>). The fractured surface on the bottom of the stern is cut clean at in front of the transverse bulkhead.

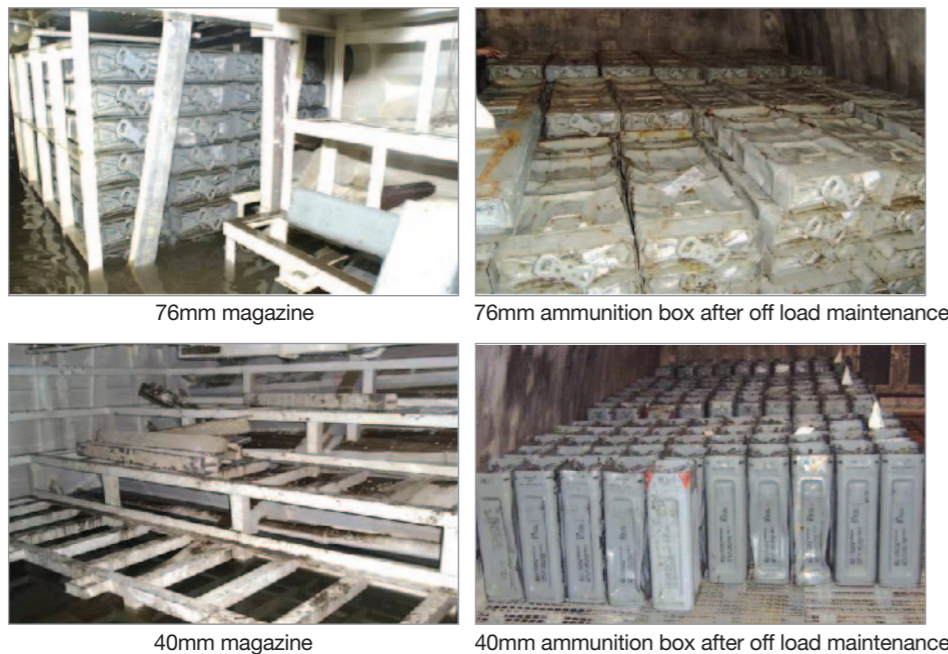
〈Figure II-2-3〉 Conditions of magazines after the hull recovery

In addition, the salvaged ammunition cases were only bent as a result of the water pressure without traces of an explosion(See 〈Figure II-2-3〉).

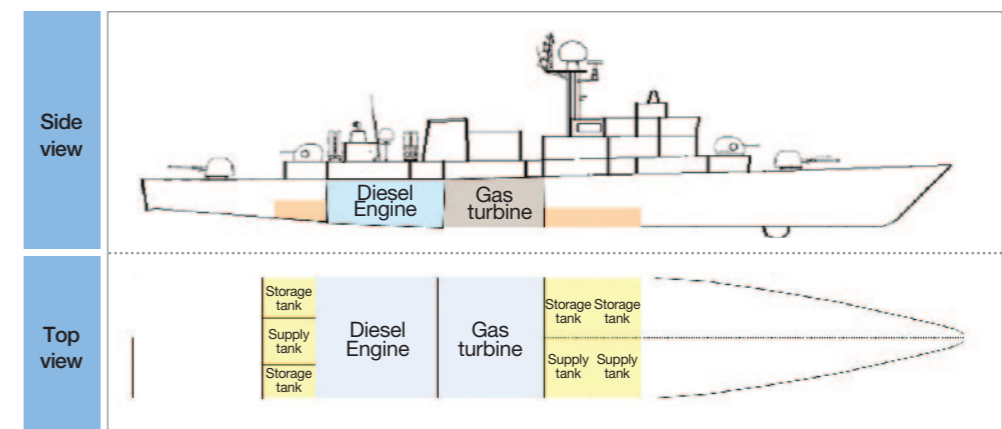
〈Figure II-2-5〉 Location of fuel tank of ROKS Cheonan

〈Figure II-2-5〉 illustrates the fuel tank locations of ROKS Cheonan. No damaged conditions were found after the inspection on these tanks, the remaining fuel was preserved, with no traces of fire or an explosion observed.

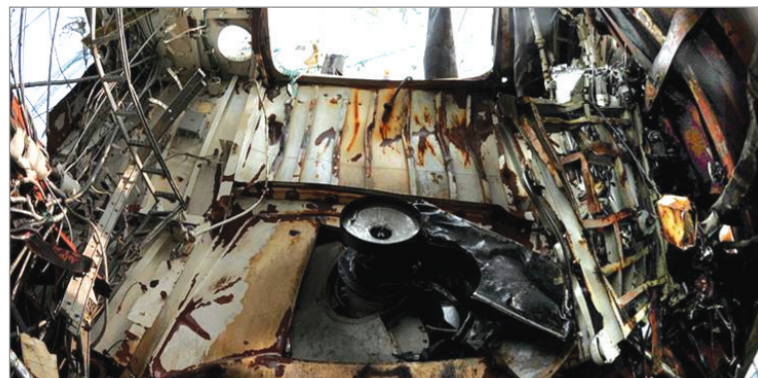
〈Figure II-2-10〉 Bulkhead between gas turbine room and diesel engine room

Although the life cycle of the gas turbine had been exceeded, regular maintenance had been conducted, and the gas turbine had been in operation for only 25% of the hours set for dismantle maintenance under fine condition of continuing operation. Based on the structural characteristics of the gas turbine, the possibility of an explosion is highly unlikely, not to mention how the ship operated safety measures that would have prevented a large scale fire from the gas turbine room spreading to other areas of the ship. In addition, the gas turbine was not in operation at the time of the incident. Therefore, it was concluded that a gas turbine defect is not the cause of the incident.

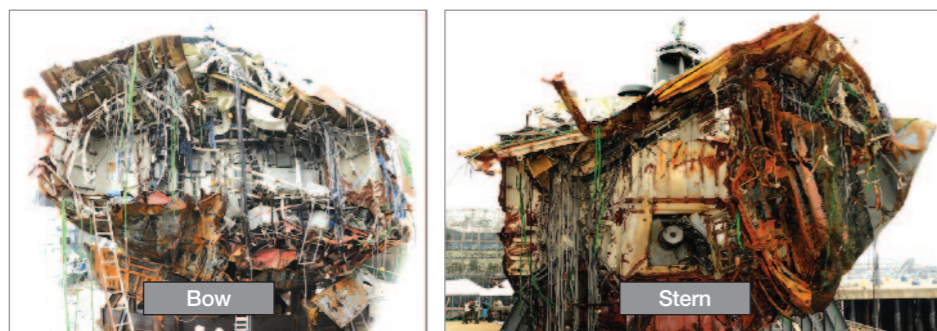
<Figure II-3-2> Breakplane of bow and stern

A summary of our investigation following the salvage of ROKS Cheonan is shown in <Figure II-3-2>. The hull was severed through the gas turbine room and approximately 7.8m

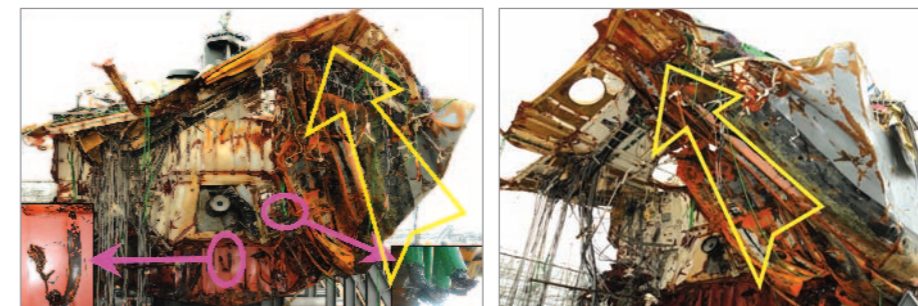
<Figure II-3-3> Direction of the deformation, PORT-bottom → STBD-top

Concerning the fractures of the breakplane as shown in <Figure II-3-3>, the lower part of the port was severed(shear fracture) by an instantaneous upward force; the bottom part was torn(brittle fracture) by a strong force in a short time; and other parts showed fractures due to large tensile force. Therefore, the shape of the damaged structure indicated typical bubble effect, where the explosion occurred below the port side of the gas turbine room and caused the ship to sever as the explosion power was exerted in an upward and starboard side direction.

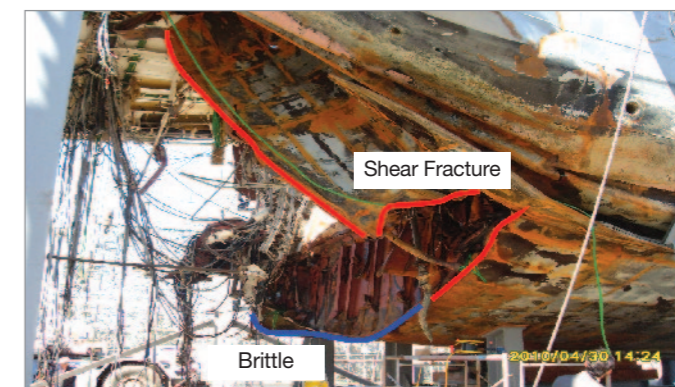
<Figure II-3-4> Shape of the split section

In addition, there were no craters observed on the top part of the salvaged hull, with no heat damage in the breakplane and no evidence of fire in any part of the ship. The electric and other wires did not show signs of melting or any other heat damage. Rather, they
