Appendix

- I. CCTV Recovery and Analysis Result
- II. Underwater Explosion Phenomenon
- III. Analysis Result on Direction and Location of the Explosion
- IV. Analysis Result on Charge Size and Depth
- V. Analysis Result on Adhered Materials
- VI. Stability Analysis Result
- VII. Basic Hull Strength Analysis Result

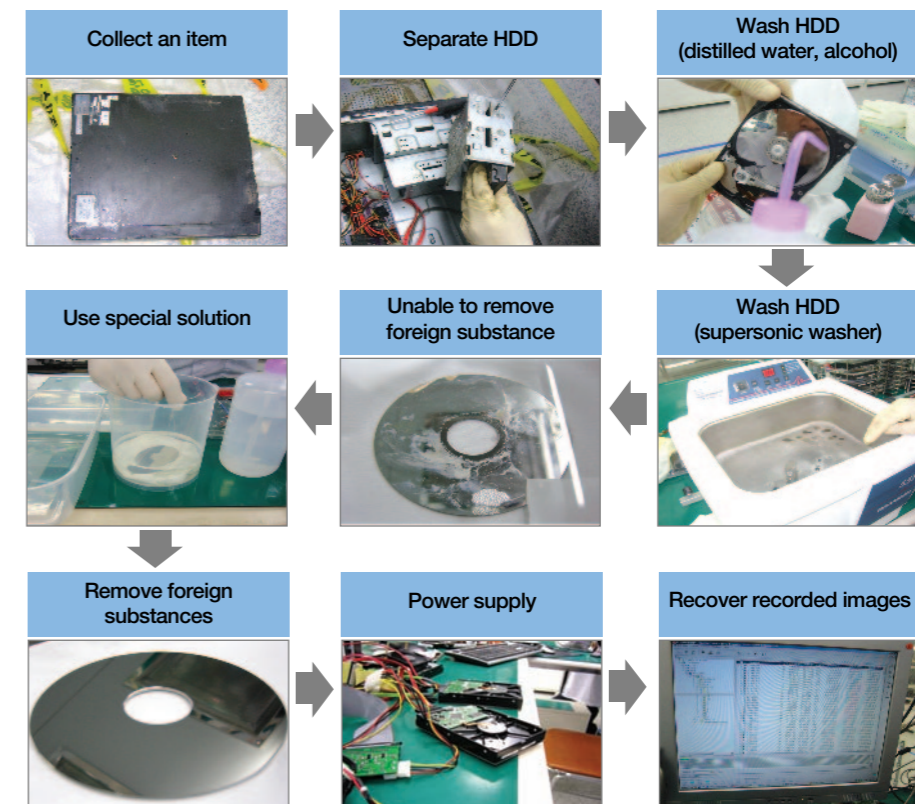
The CCTV recovery operation was hampered due to oil, mud, and other foreign substances that were attached to the hard drive for over a month. Through the spraying of pure alcohol, distilled water and thinners along with ultrasound waves(these are the most effective means for success) for 6 days, the JIG made repeated attempts to remove these substances; however, the attached foreign substances could not be completely removed.

The JIG requested for a composition analysis on the foreign substance to the KCIC scientific investigation lab. The foreign substance was composed of Al, and NaOH was identified.

〈Figure Appendix I-2-1〉 CCTV recovery process

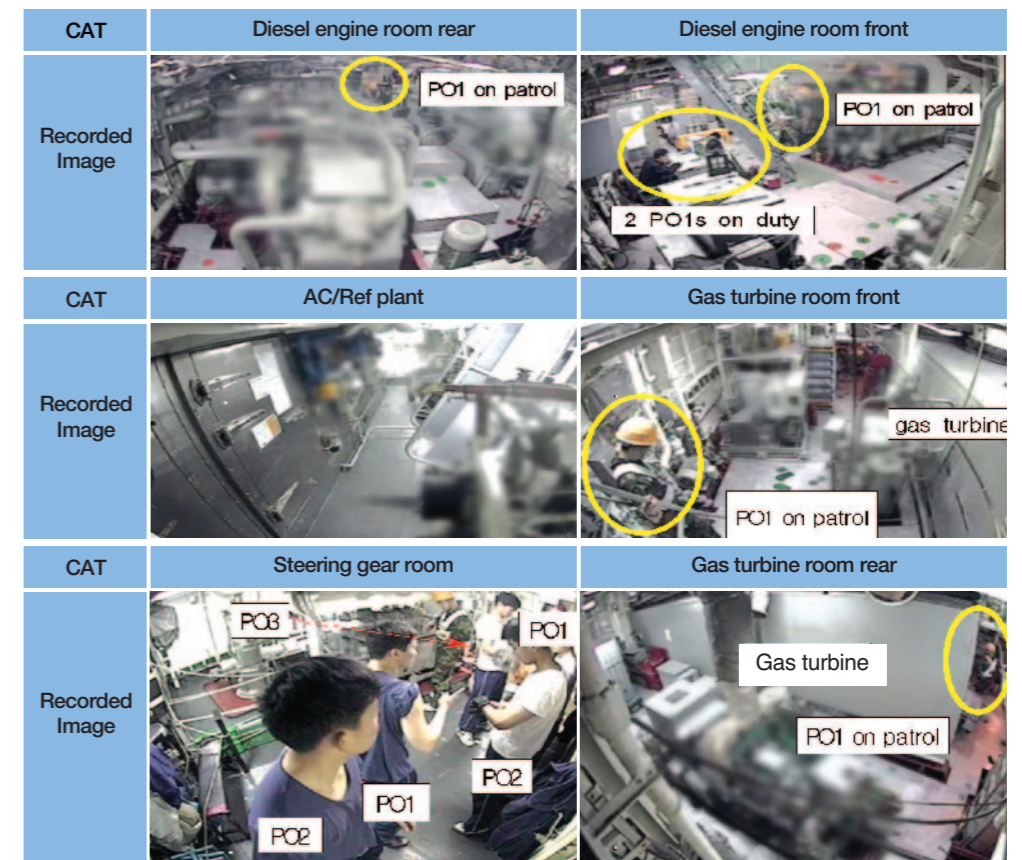
Because of the way the settings were set up for ROKS Cheonan's 11 CCTVs, the initially inserted recording time did not get updated, and this resulted in a time difference with the actual time of recording. The CCTV begins recording when movement is detected, and the images are saved 1 minute after the recording. After taking this setting into account as well as the statements from survivors, the analysis showed that the CCTV that recorded the latest time frame was the one that was located in the gas turbine room, and the JIG estimated it to have halted recording at 2121 hours(21:17:03 on the CCTV time).

〈Figure Appendix I-3-1〉 CCTV recorded footage

From the recovery, the images of the gas turbine room and diesel engine room were confirmed, as well as those of the patrolling of a safety watch, and other crew members exercising in the steering gearing room. Based on the routine circumstances in the observed compartments, outfits and facial expressions of crew members, along with stable sailing status, it was concluded that ROKS Cheonan was on normal operations without any emergency situation such as grounding, until a sudden explosion fractured the hull and caused the sinking.

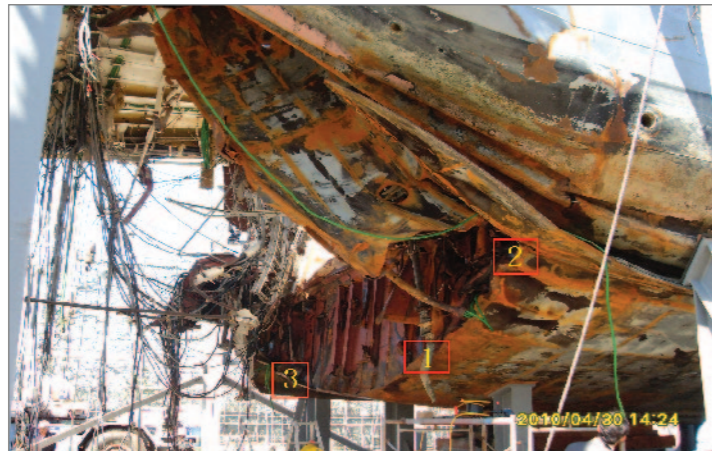
The first on-site investigation was conducted on April 30, and the breakplane of the stern hull bottom was observed. As shown in <Figure Appendix III-1-1>, samples of approximately 15cm × 15cm size were collected from three locations at the breakplane of the stern hull bottom. The second on-site investigation was conducted on May 4, to check the probable direction of fracture on the bottom of the stern hull, and to observe the breakplane on flank of the stern hull as well as on the bottom and flank of the bow hull. On May 10, the third on-site investigation was conducted in order to check the direction of fracture on the bottom and flank of the bow, and breakplane of main deck of the bow and stern was observed.

<Figure Appendix III-1-1> Sample collection locations at breakplane

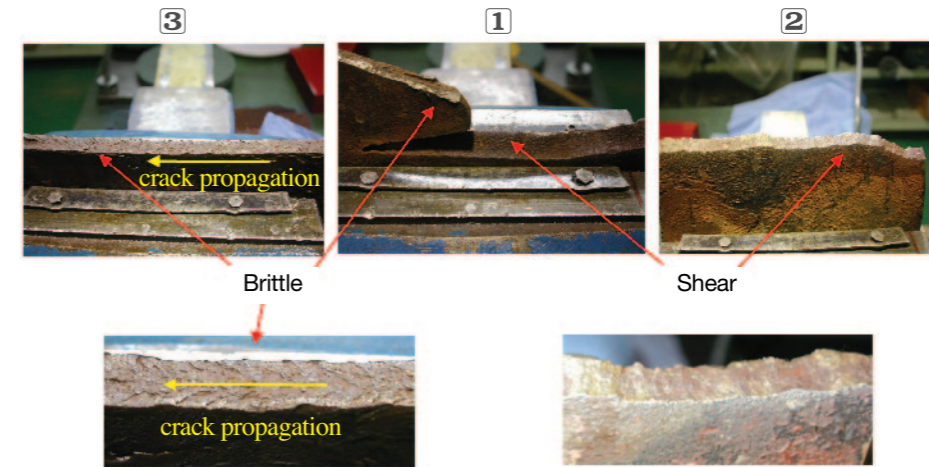
All the fractured surfaces of the samples, as shown in <Figure Appendix III-2-1>, were identified to be shear and brittle fractures with no signs of ductile or fatigue fracture. Sample #2 shows shear fracture patterns and sample #3 shows a typical brittle fracture, whereas sample #1 contains a mixture of the two.

<Figure Appendix III-2-1> Fracture surfaces of collected samples

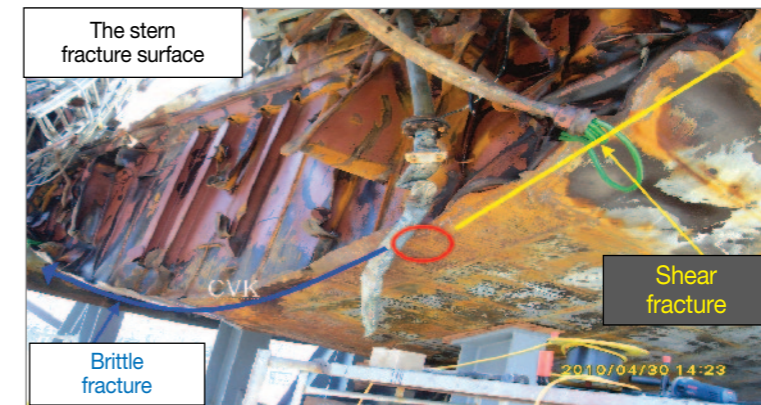
Additional visual observation was made on May 4, and it was confirmed that the pattern showed shear fracture between sample locations #1 and #2 and brittle fracture between sample locations #1 and #3 as shown on <Figure Appendix III-2-2>.

Therefore, it was estimated that one third of breakplane on the port side of the stern hull underwent shear fracture caused by instantaneous external force, and the rest of bottom part of the stern hull suffered brittle fracture caused by tensile force. And the origin of crack was estimated to be near sample location #1.

<Figure Appendix III-2-2> The pattern of fracture on the stern

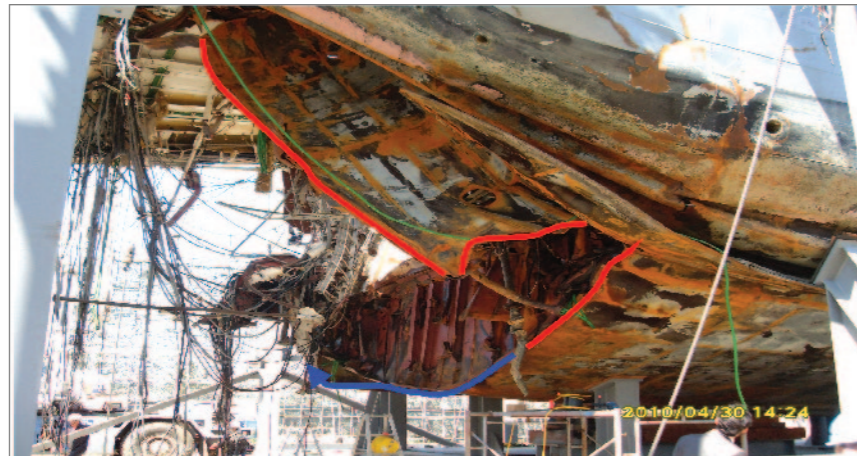
As shown in <Figure Appendix III-2-3>, it was confirmed that in the fractured surface of the stern part, shear fracture(highlighted in red) occurred in the estimated region of direct impact, and that brittle fracture(highlighted in blue) occurred starting where shear fracture ends, towards the starboard side. In addition, all of the three fractures on the port side, which was rolled up into a U-shape, also showed shear fracture patterns.

<Figure Appendix III-2-3> Overall fracture pattern of the stern part

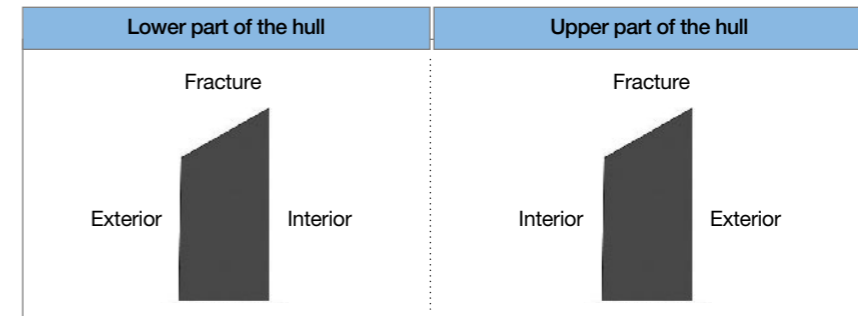
The brittle fracture patterns were observed in the vicinity of the keel for both the bow and stern part, and the shear fracture patterns were shown in all the rest. The estimated origin of the brittle fracture was the lower-left part of the port hull(near sample location #1). In the lower part of the port side and starboard side of both the bow and stern that show the shear fracture patterns, the overall cross section was slanted from the vertical direction and lifted higher towards the interior of the hull as shown in <Figure Appendix III-2-4>(the di-

For the port and starboard sides of the upper main deck of both the bow and stern, the overall section was also slanted; however, the direction was reversed and oriented higher towards the exterior of the hull as can be seen in <figure Appendix III-2-4>(the diagram on the right) at every location.

<Figure Appendix III-2-4> Shape of fracture on the hull

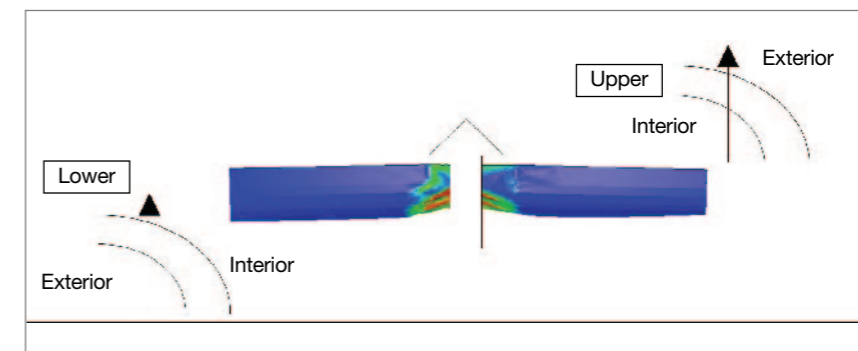
The situation that could have caused the aforementioned section shapes, as shown in <Figure Appendix III-2-5>, was estimated to happen when a large plastic deformation occurs first to curve the outer structure of the ship, followed by a shear fracture caused by a strong, uni-directional external force(presumably water jet).

<Figure Appendix III-2-5> Analysis of cutting shape of upper and lower hull

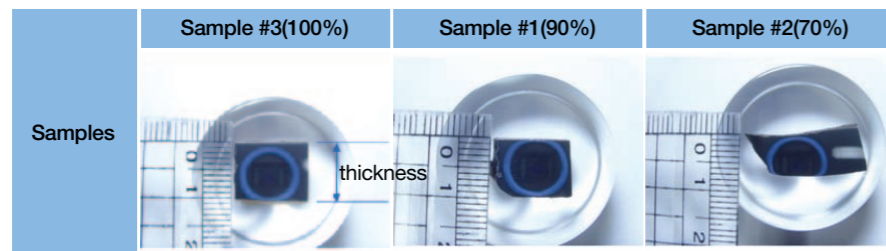
From the measurement of the thickness of collected samples, sample 2 which was estimated to be near the origin of explosion showed to be 30% less thick than sample 3 at starboard side, while sample 1 showed 10% less compared to sample 3, as shown in <Figure Appendix III -3-1> below.

<Figure Appendix III-3-1> Thickness measurement of collected samples

This confirmed the assessment mentioned earlier that a plastic deformation with substantially large curvature occurred at the port side bottom before fracture.

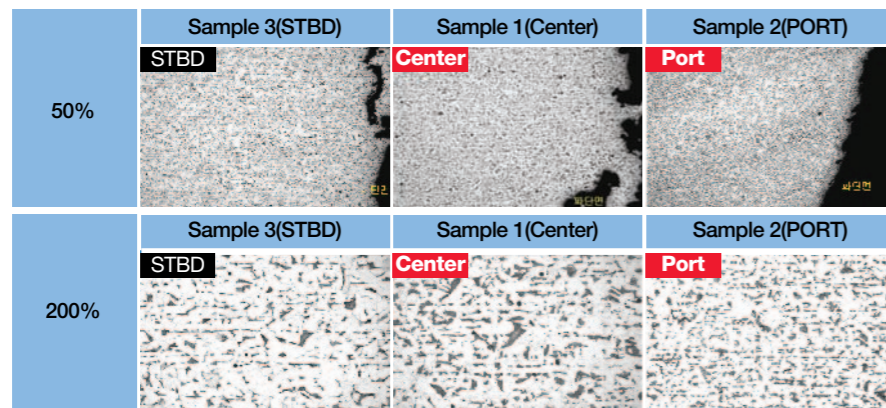
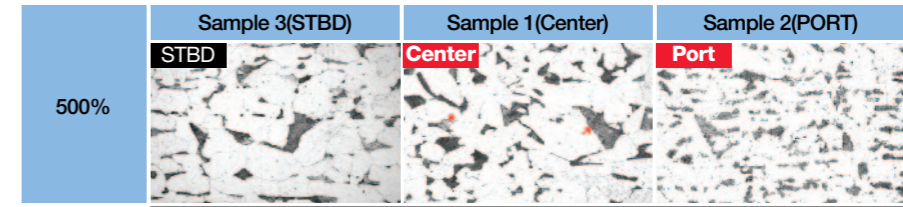
<Figure Appendix III-3-2> Microstructures of collected samples

The observations of the microstructures of each sample and the results are shown in the <Figure Appendix III-3-2>.

For the 200× magnified images, the sample 2 showed the stripes spaced closer and thinned out compared to sample 3 collected from starboard side, and showed typical pearlite + ferrite⁹⁾ microstructure. The black parts were pearlite structure. If there were a heat deformation on the portside, as shown in <Figure Appendix III-3-3>, rolling stripe melting due to pearlite coarsening should be observed; however, since such phenomena were absent on the samples, it was confirmed that there had been no heat over 723℃. This can be a basis in proving the cause as a non-contact external explosion.

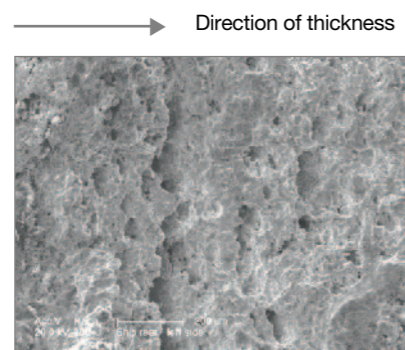
As the microstructure of the sample 2 from portside was observed, numerous cavities grown perpendicular to thickness appeared as shown in 〈Figure Appendix III-3-4〉, which indicated a strong tensile force having been applied in the direction of thickness. This tensile force was caused to be from the tensile wave due to the interaction between shockwave in the direction of thickness and rarefaction wave¹³⁾ on the opposite free surface side of the impact. Therefore, this was another basis that could prove the strong impact upon the portside bottom.

〈Figure Appendix III-3-4〉 A microstructure of fractured surface

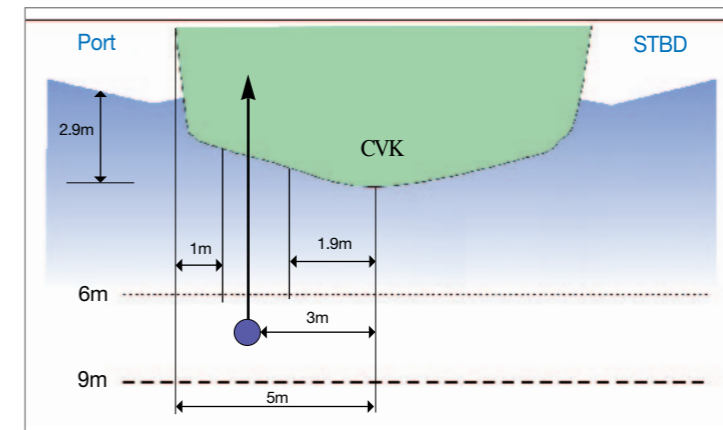
The analysis on the breakplane of ROKS Cheonan revealed that an upward plastic deformation with large curvature due to a strong explosion from the portside bottom occurred(hogging), and then, a strong external force, presumably water jet, caused shear fracture which began at 1.9m left of the CVK. Thus, given that the hull is 5m in half breadth of the port, it could be estimated that an explosion might have occurred between 1.9~5m left of the CVK. The possible location for a torpedo strike could be estimated to be 3m, which is the center of 1.9~4m range left of the bottom CVK(See 〈Figure Appendix III-4-1〉).

〈Figure Appendix III-4-1〉 Possible range of torpedo explosion

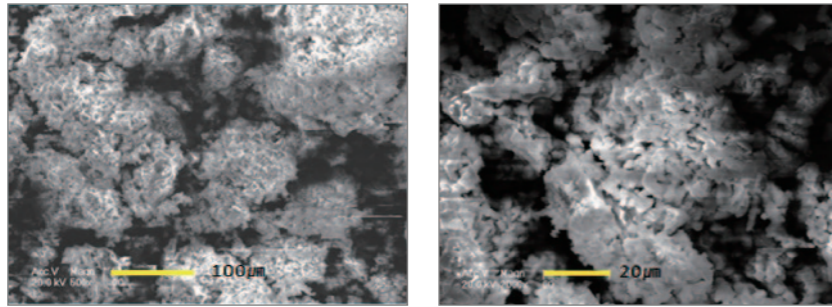
The SEM images of the adhered material are shown in <Figure Appendix V-1-1>. Fine particles were agglomerated as if melted.

〈Figure Appendix V-1-1〉 SEM Images

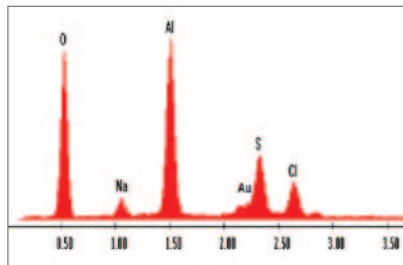
For EDS analysis, electrons of an atom are ejected upon irradiation of an electron beam, and subsequently the hole is filled with other electrons from higher shells which accompany energy release. Since the released energy is different for each element, the elements composing of a material can be identified. As presented in 〈Figure Appendix V-1-2〉, the EDS results show that the adsorbed material consisted of oxygen, sodium, aluminum, sulfur, and chlorine(The Au(gold) peak was observed due to the gold plating on the sample necessary for the experiment). Based on the elemental composition, the adhered material was considered to be a mixture of oxides of aluminum(Al_xO_y), salt(NaCl), and sulfur or sulfur compounds.

〈Figure Appendix V-1-2〉 EDS result

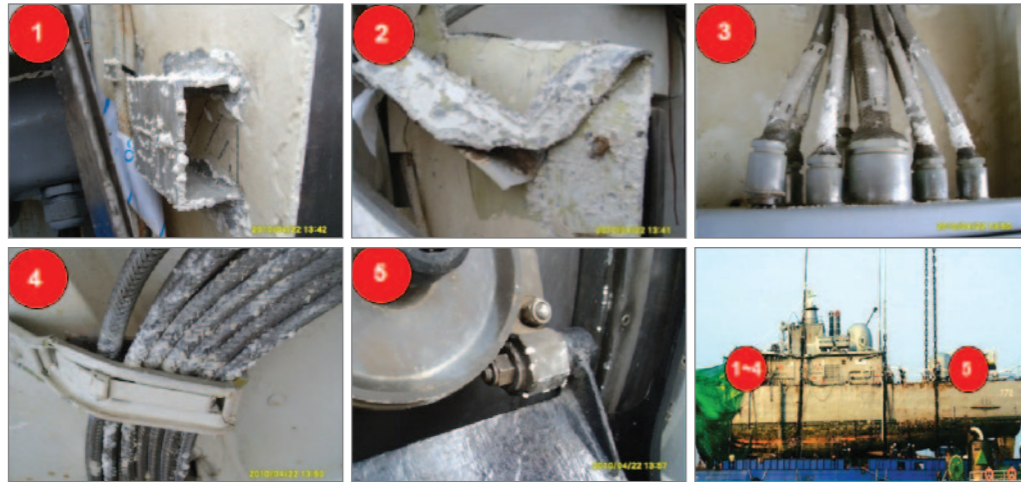
Based on the first analysis results, samples were collected from five different locations on the stern on April 22, 2010 to perform more extensive analysis. Sample locations were near the center of the fracture plane, where a significant amount of the adhered powder was found, and included surfaces of different types of materials(aluminum and non-aluminum). The team also sampled from the 76mm naval gun barrel which was relatively far from the fracture plane.

〈Figure Appendix V-2-1〉 Sampling locations

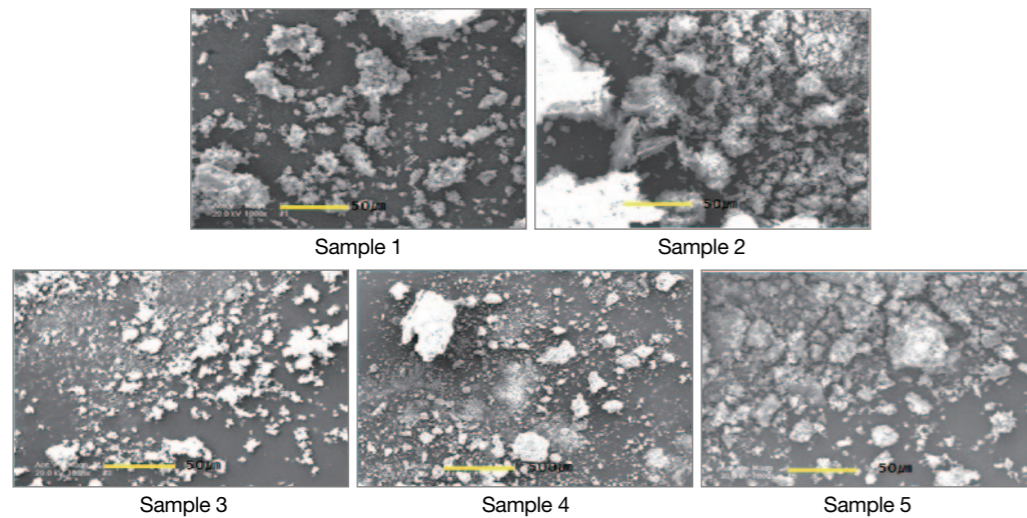
The SEM images of the collected samples showed agglomerates of fine particles, which were similar to those obtained in the first analysis(See 〈Figure Appendix V-2-2〉). In the EDS analysis, the detection range was increased to detect elements with low atomic weight, and consequently the carbon was detected.

〈Figure Appendix V-2-2〉 SEM images of the adhered material(stern)

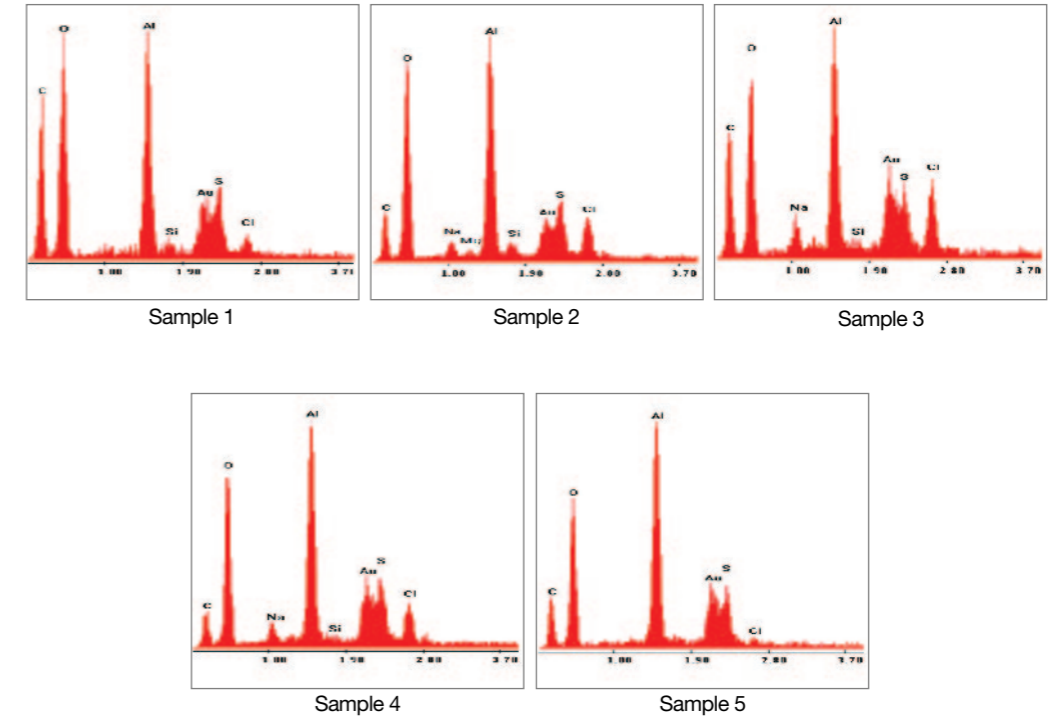
As shown in 〈Figure Appendix V-2-3〉, all samples consisted of carbon, oxygen, sodium, magnesium, aluminum, silicon, sulfur, and chlorine. This result was similar to that of the first analysis. Considering the elemental composition, the adhered material consisted of oxides of aluminum(Al_xO_y), salts($NaCl$, $MgCl_2$, etc.), and sulfur or sulfur compounds.

〈Figure Appendix V-2-3〉 EDS results of the adhered material(stern)

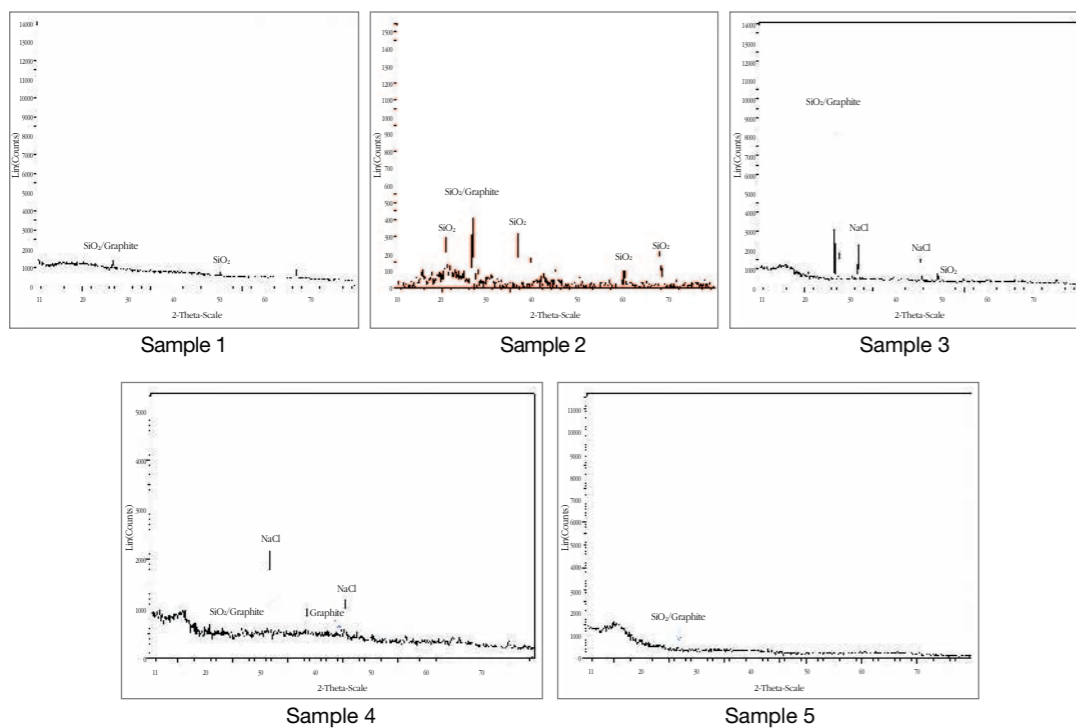
The XRD results showed silicon dioxide(SiO_2), graphite, and salt($NaCl$) crystals from the adhered material. The overlap of the peaks of silicon dioxide and those of graphite made it difficult to distinguish one another, but a small peak at 44.5° diffraction angle clearly identified the presence of the graphite(See 〈Figure Appendix V-2-4〉 sample 4). The EDS results showed that the main component of the adhered material was oxides of aluminum, and the XRD results confirmed that the oxides of aluminum were amorphous.

〈Figure Appendix V-2-4〉 XRD results of the adhered material(stern)

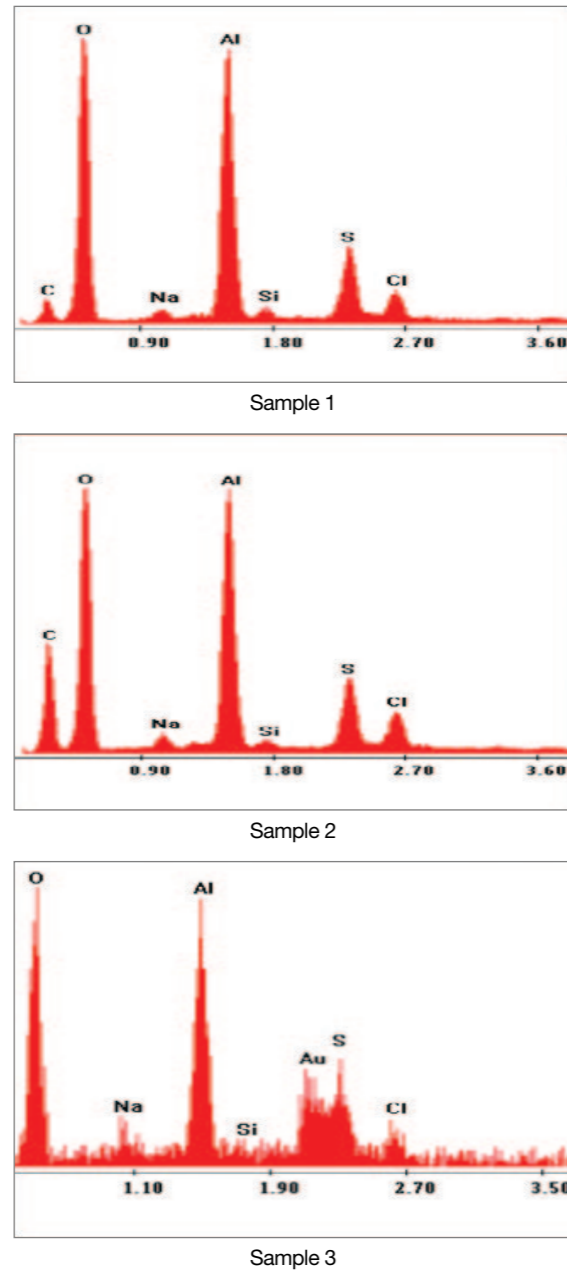
As shown in <Figure Appendix V-3-2>, the EDS analysis results showed that the adhered material from both the bow and stack consisted of carbon, oxygen, sodium, magnesium, aluminum, silicon, sulfur, and chlorine. This result was similar to those of stern side samples.

<Figure Appendix V-3-2> EDS results of the adhered material(bow and stack)

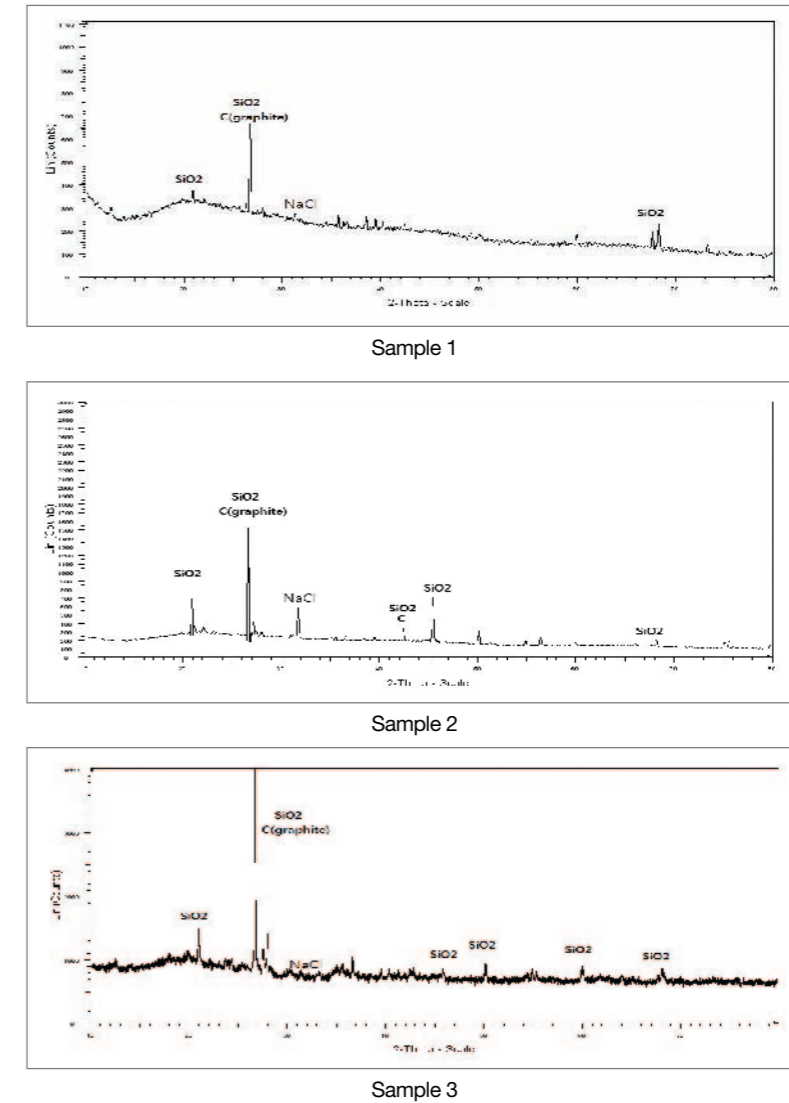
The XRD results confirmed that silicon dioxide(SiO_2), graphite, and salt(NaCl) crystals were present from the adhered material and that the main component of the adhered material was oxides of aluminum. These results are in good agreement with those of stern sample(See <Figure Appendix V-3-3>).

<Figure Appendix V-3-3> XRD results of the adhered material(bow and stack)

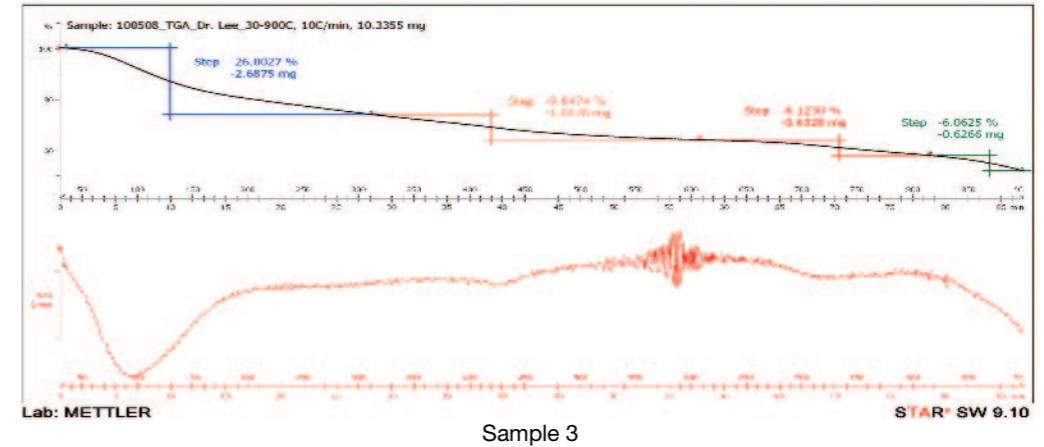
The pyrolysis results were similar to those results from the stern samples(See 〈Figure Appendix V-3-4〉).

〈Figure Appendix V-3-4〉 TGA results of the adhered material(bow and stack)

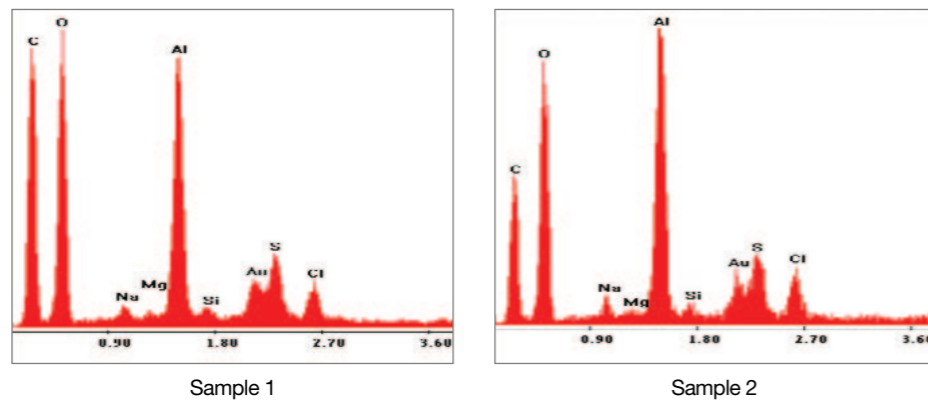
As shown in <Figure Appendix V-4-2>, the EDS analysis results showed that the adhered material consisted of carbon, oxygen, sodium, magnesium, aluminum, silicon, sulfur, and chlorine. Those results were similar to those of hull samples.

<Figure Appendix V-4-2> EDS results of the adhered material(propulsion section and motor)

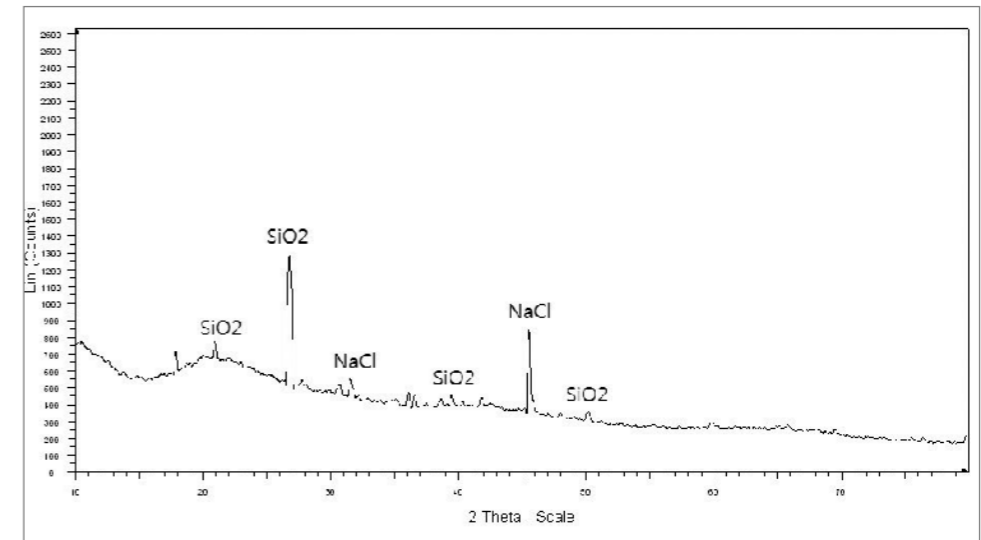
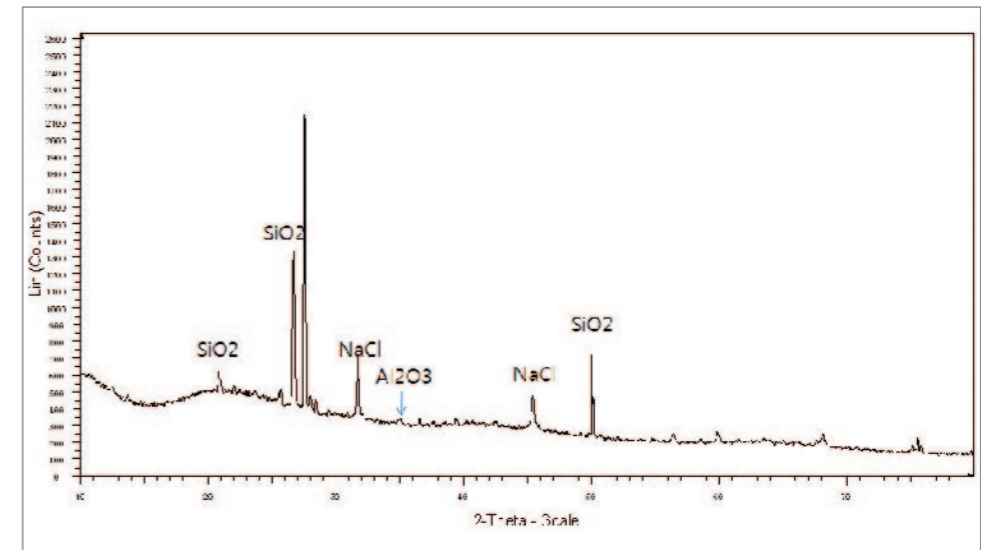
The XRD results confirmed that silicon oxide(SiO_2) and salt(NaCl) crystals were present. The peak positions of the two samples were reasonably similar. Although the peak size was almost negligible, an aluminum oxide(Al_2O_3) crystal peak was also observed(See <Figure Appendix V-4-3>).

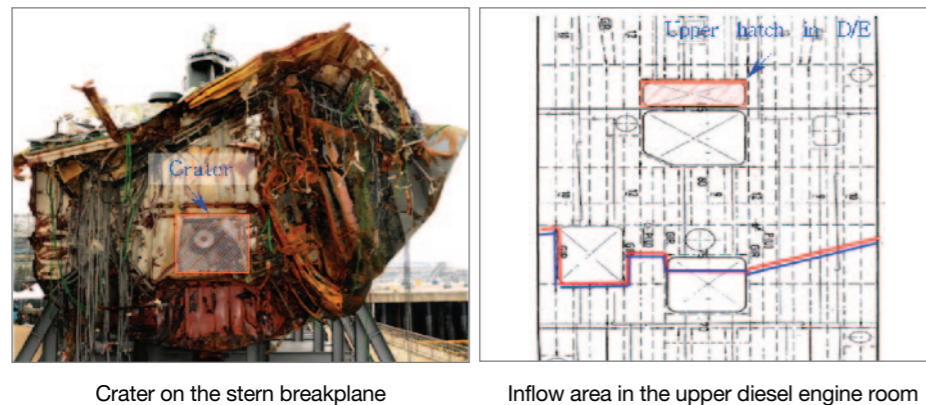
(Figure Appendix VI-5-4) Crater on the stern breakplane & the main deck hatch
