**On the Attack
Against ROK Ship
Cheonan**

Ministry of National Defense
Republic of Korea

September 2010

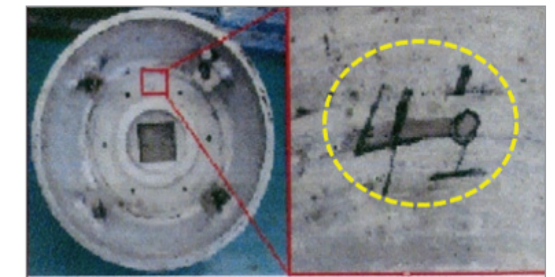
<Figure Summary-5> Marking on **North Korean** test torpedo

These evidences confirmed that the recovered torpedo parts were manufactured in **North Korea**.

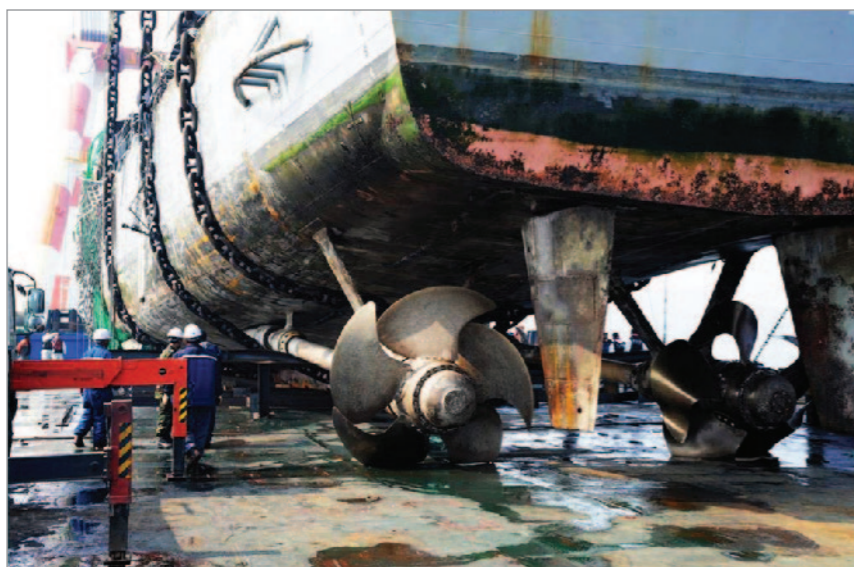
〈Figure II-1-2〉 ROKS Cheonan propellers upon the recovery of the stern

Also, after examining the deformation of the starboard propellers, it was assessed that

the break of the blades or global scratch marks were absent, which would have occurred in case of grounding, but no such traces were found. Instead, 5 blades were bent toward the bow side in a symmetric manner(See 〈Figure II-1-7〉). The Swedish Investigation Team assessed that this type of deformation cannot occur due to a grounding event, and concluded the possible cause as the mass force of inertia, which was created from the sudden halt of the propeller rotation, and propulsion shaft being pushed severely.

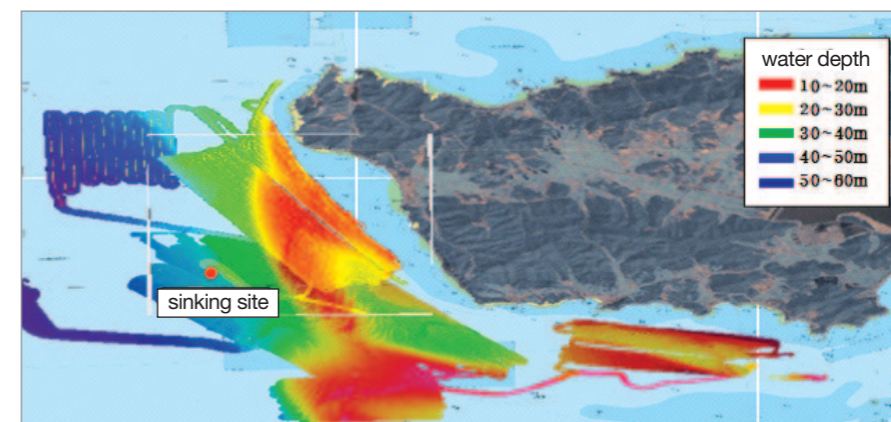
〈Figure II-1-8〉 Probing result of seafloor geography in incident site

According to the data of ROKS Cheonan, the draft of the ship is 2.88m. Judging from the growth of seaweed remaining on the hull, operational draft is estimated to be an average of less than 3.1m. The water depth of the incident site is 47m. It is known that the depth at the shallowest point around the operational area is 8.6m, thus leaving no possibility for ROKS Cheonan to make contact with the seabed. In addition, there were no obstacles identified in the water after thorough probing on the incident site from March 28 to May 8 with 4 Navy mine sweeping vessels and 2 investigation vessels from KORDI(See 〈Figure II-1-8〉). It was also discovered that artificial reefs were placed at depths of around 17~34m. This also leaves no possibility of contact with the seafloor. These facts were verified by the Australian Investigation Team.

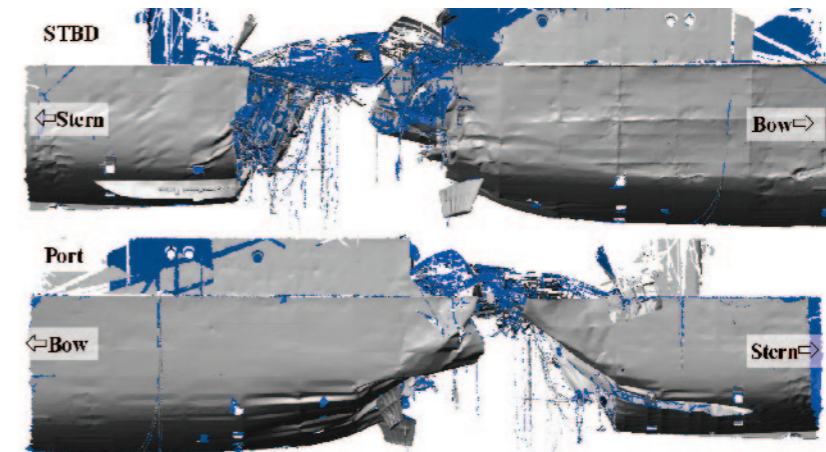
<Figure II-1-9> Fractured areas of ROKS Cheonan

When observing the fracture shape of ROKS Cheonan on the sides(See <Figure II-1-9>), there are no apparent fractures and debris that resemble a bow of an incoming ship. Furthermore, the overall fracture status indicates a massive upward force originated from the bottom. Additionally, the dishing effect apparent on the bottom plate of the ship, shown in

<Figure II-1-3>, is a deformation that cannot occur through a collision but can be seen as a result of intense shock pressure from underwater.

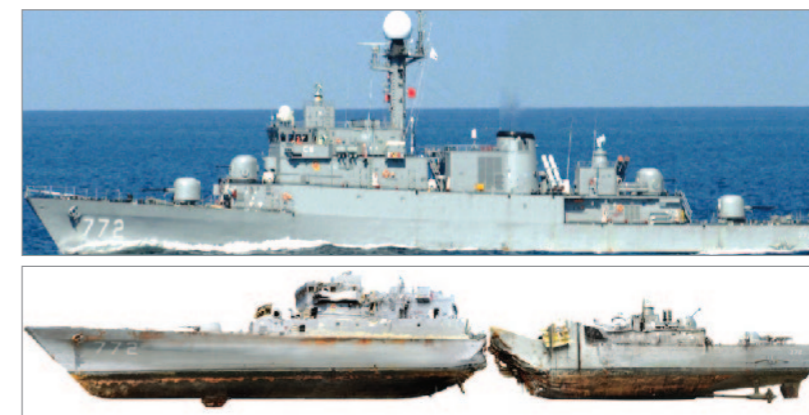
<Figure II-2-1> Shape of damage on ROKS Cheonan

TOD footage showed that ROKS Cheonan was sunk and broken in half. It was confirmed following the recovery of the ship that it had been split up in the middle.

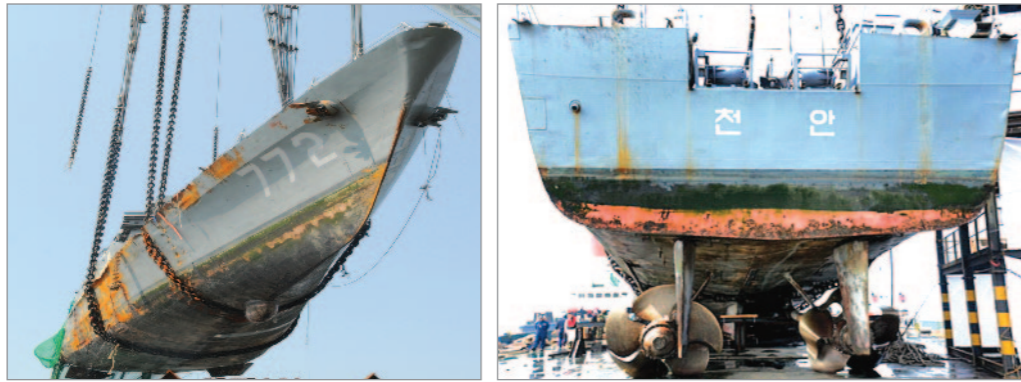
〈Figure II-2-2〉 Conditions of the bottom of bow and stern

Investigation on the exterior of the stern and the bow, where 40 and 76mm magazines are located, showed that no upper iron plates of the waterline had undergone bending effects. In addition, the magazines showed no trace of internal damages, and there was no deformation in an outwardly direction on the magazine bulkhead and no damages resulting from fragments. Furthermore, no leftover fragments were found.

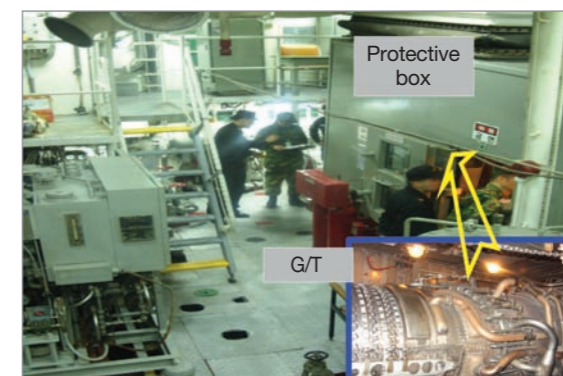
〈Figure II-2-9〉 Gas turbine protective box

uses diesel fuel by design, its explosion is highly unlikely. There is a slight possibility of fire(almost none), but the gas turbine is inside a protective box, and thus the possibility of fire spreading to the rest of the ship is next to none. Even if fire occurs, there are fire detectors and extinguishers equipped in the protective box to put the fire out. Therefore, fire from the gas turbine would not lead to an explosion of the ship.

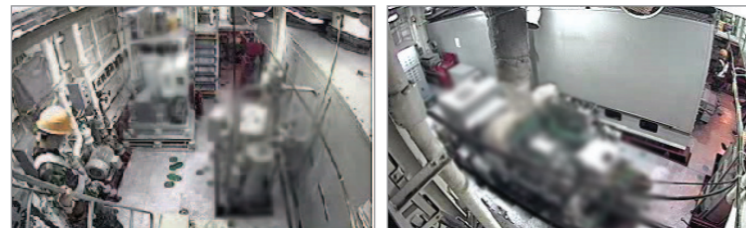
〈Figure II-2-11〉 Gas turbine room just before the incident(CCTV)

After recovering the bow and stern of ROKS Cheonan, it was found that the gas turbine room had been lost. However, after an extensive search, components of the gas turbine were recovered. There was no trace of damage holes to the bulkhead between the gas turbine room and the diesel engine room which would have been produced by an engine damage. In case of the gas turbine damage, the turbine blades would disperse and create damage holes on the nearby walls. The CCTV footage recorded up to the incident also shows no indication of damage to the gas turbine or fire. Also, the survivor statements indicate that ROKS Cheonan was maneuvering at a speed of 6.7kts and therefore was not operating the gas turbine.

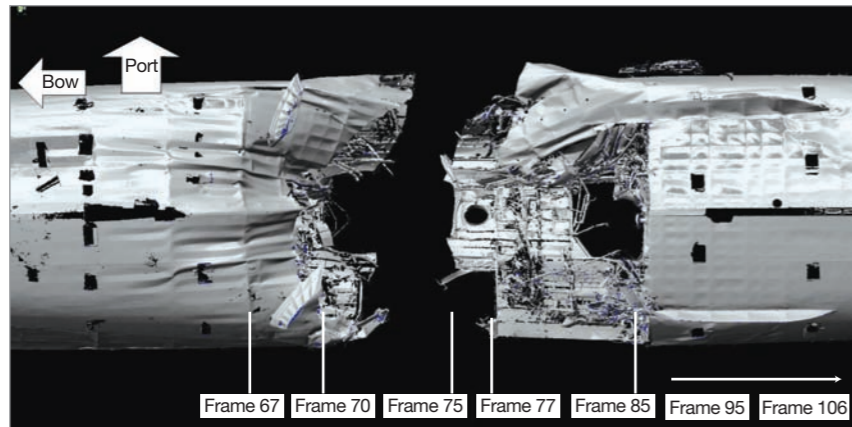
〈Figure II-3-16〉 3D laser scan image on the split section of ROKS Cheonan

ROKS Cheonan was broken in half by a whipping effect and upward bubble pressure on the port side bottom area of the gas turbine room towards the starboard side. The CVK and the fractured surface were twisted and ripped upwards. The CVK area is where the gas turbine engine was installed and the parts of the ship bottom were blasted away while the stiffeners and the ship structure reinforcements were crushed inward and on top of each other towards the starboard due to pressure. Wires on the port side and the starboard side were cut from tensile force. No traces of fire, soot, and laceration that would indicate internal fire were found. Additionally, sectional paint jobs on the bottom of the hull were scratched off in a wide range.

After Frame 106, no traces of damages from impact were found. In regards to the port side shell plating, local bending of plating appeared from the severed area to Frame 95. As for the starboard plating, local bending of plating appeared from the severed area to Frame 90. Additionally, areas from Frames 67 to 70 were significantly bent in an upward direction.

There were significant deformations on the external plating of the stern section between Frames 75 and 85 on the port side, and significant deformations were observed be-

tween Frames 70 and 71 on the bow section. The platings were bent severely in a round shape towards the inside. The stern CVK was deformed towards port in the main deck direction of the stern(upward direction). Furthermore, a significant bending appeared on the severed CVK from Frames 70 and 85. This effect is highly likely to have taken place during the initial sagging of the hull which would have been generated by the tensile force.

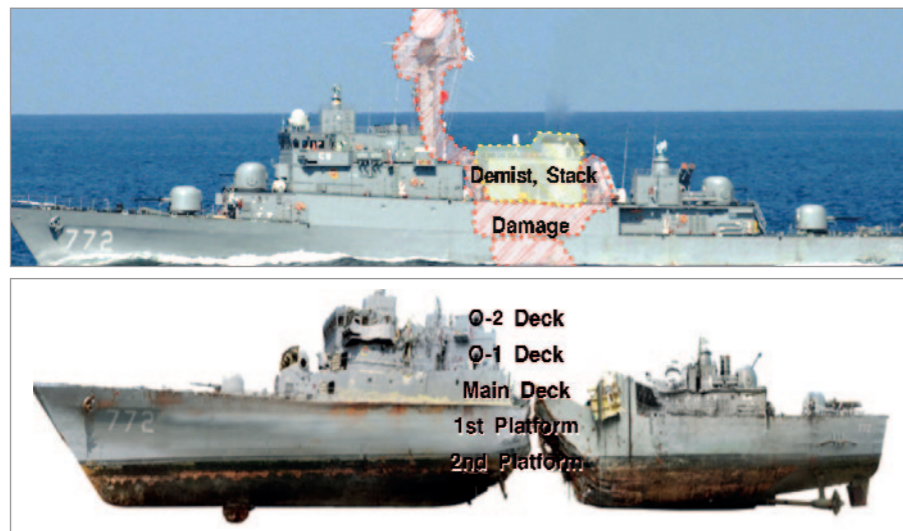
〈Figure III-1-1〉 Overall shape

The overall length of ROKS Cheonan is 88.32 meters. The 3D precision measurements using a 3D scanned image of the ruptured bow and stern and the actual measurements of the hull indicate that the breakplane was located at the center of the gas turbine room(47.6m from the portside, and 45.4m from the starboard side).

When the ruptured parts were fitted together, the portside had resulted in an outer shell length of 50.32m in the bow and 38m in the stern, and hence experienced no loss except for the parts of the stern hull bottom. However, the starboard side had experienced a 7.8m loss with the bow part being 47.2m and the stern part being 33.32m long. The degaussing room on the main deck, CPO mess hall, machine control room, construction storage, crews'

galley, demist and stack on the O-1 deck, and harpoon missiles were lost. These losses were localized at the upper and lower parts of the gas turbine room.

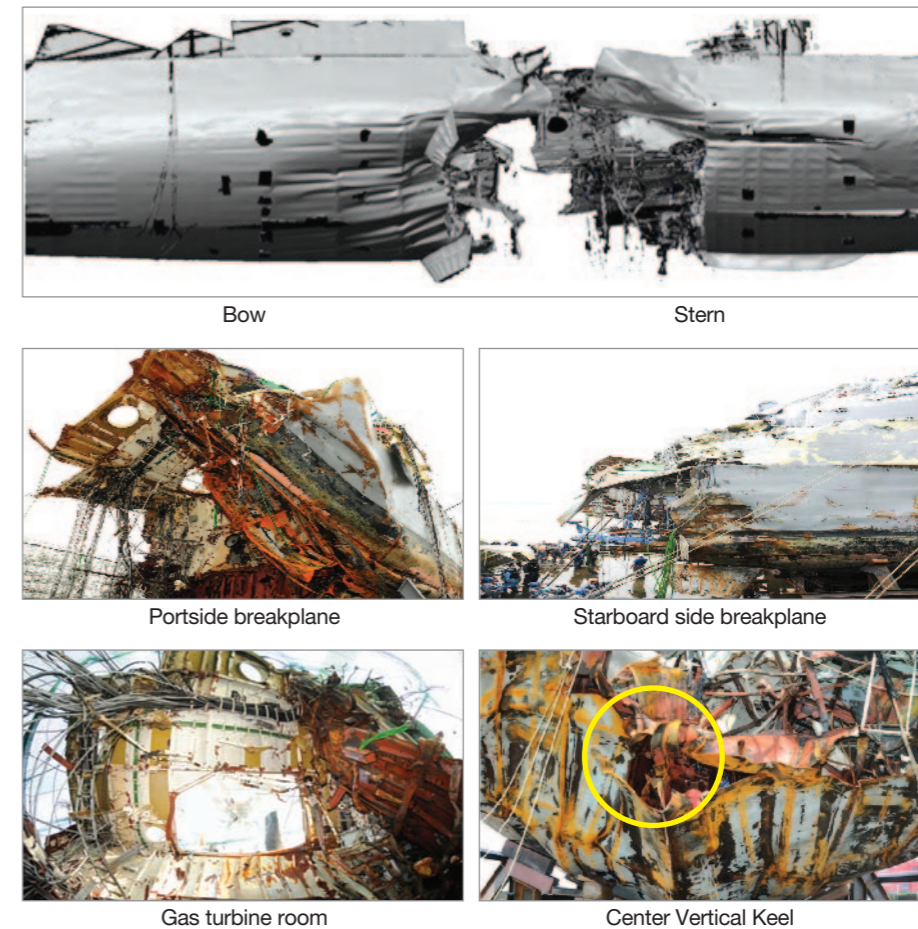
〈Figure III-1-2〉 Shape analysis

〈Figure III-1-2〉 indicates that the bow and stern's hull bottom are bent upward due to water pressure; the portside breakplane is bent and pushed upward; and 7.8m of the star-

board side is fallen off at the gas turbine room's fore and aft.

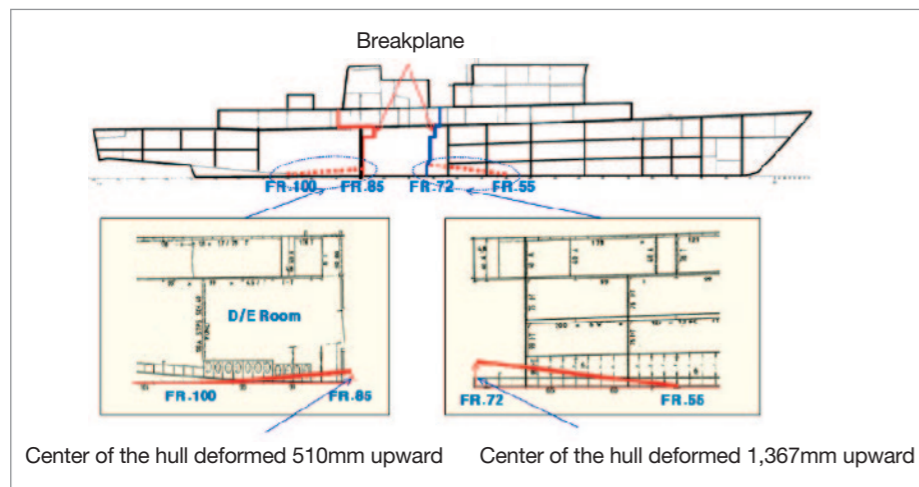
<Figure III-1-3> Starboard breakplane & CVK deformation

A precise deformation analysis was performed by 3 experts from the Defense Agency for Technology and Quality. The starboard side fracture was cut along Frame 72 and Frame 85 with a detachment of 7.8m as seen in <Figure III-1-3> and <Figure III-1-4>. The bow CVK deformation began in Frame 55 and moved upward towards Frame 72 for 1,367mm, and the stern CVK deformation began in Frame 100 and moved upwards towards Frame 85 for 510mm.

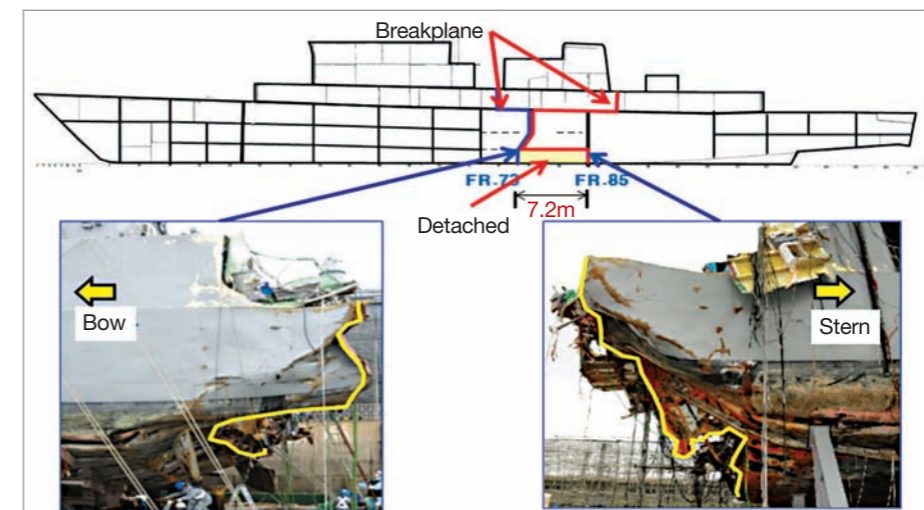
<Figure III-1-5> Portside fracture

As seen in <Figure III-1-5>, the portside was fractured from Frame 73 on, and the detached portion is about 7.2m long on the bottom. For the stern, the inside of the ship was bent upwards between Frame 85 and Frame 73(7.2m), and the bow was bent upwards from Frame 70 and 73(1.8m) on the inside of the hull. This enabled the JIG to rule out internal explosion, fatigue fracture, and grounding. It was assessed that the shock wave, generated by a strong non-contact underwater explosion initiating from the bottom portside, was delivered to the internal structures on the starboard side, and the hull was inflicted with serious damage as a result.

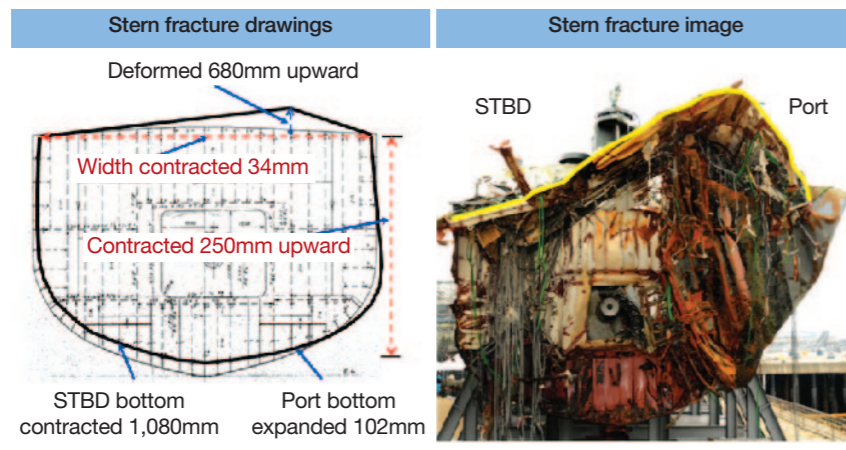
<Figure III-1-6> Stern breakplane deformation

The stern fractured surface on Frame 85, as shown in <Figure III-1-6>, shows that the center line of the ship contracted 250mm, that the portside bottom expanded 102mm along the width, and that the starboard bottom was compressed 1,080mm. The width of the Main Deck was compressed 34mm, and the hull was deformed 680mm upward from the point 3,600mm port from the center line.

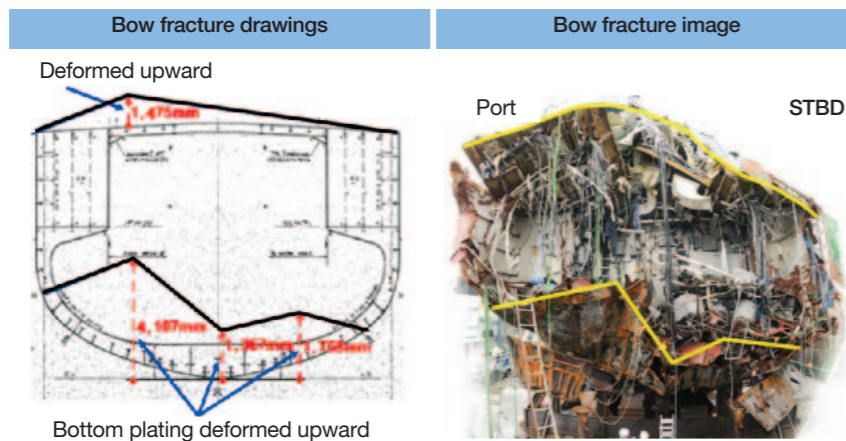
<Figure III-1-7> Bow fractured surface deformation

From the baseline, the bow fractured surface, as seen in <Figure III-1-7>, shows that the bottom was lifted upward at a maximum of 4,107mm at the point of 2,400mm to the portside. The CVK was deformed upward by 1,367mm, and the starboard bottom was bent upward by 1,758mm at the point of 1,800mm away from the baseline. The main deck was

lifted 1,475mm from the baseline at the point 2,400mm to portside.

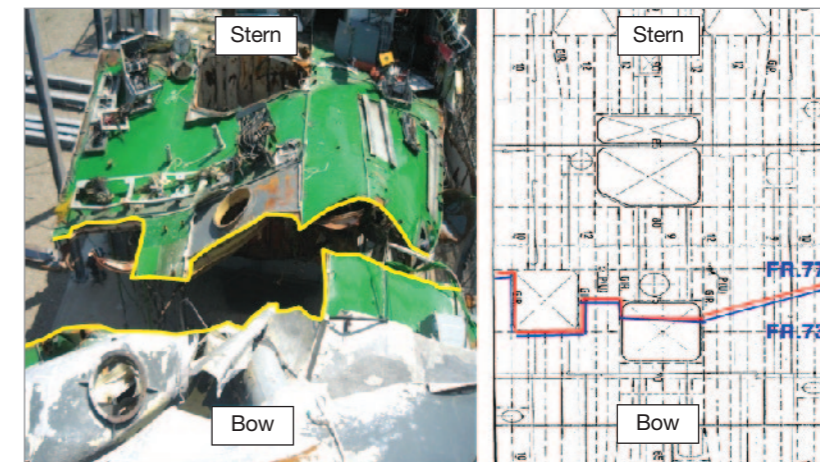
<Figure III-1-8> Main deck deformation

For the main deck, as seen in <Figure III-1-8>, the breakplane is located along Frames 73~77. The fracture occurred by the concentration of stress of an external force impacting on the round end of the deck opening, and the port side is more severely deformed upwards compared to the starboard side.

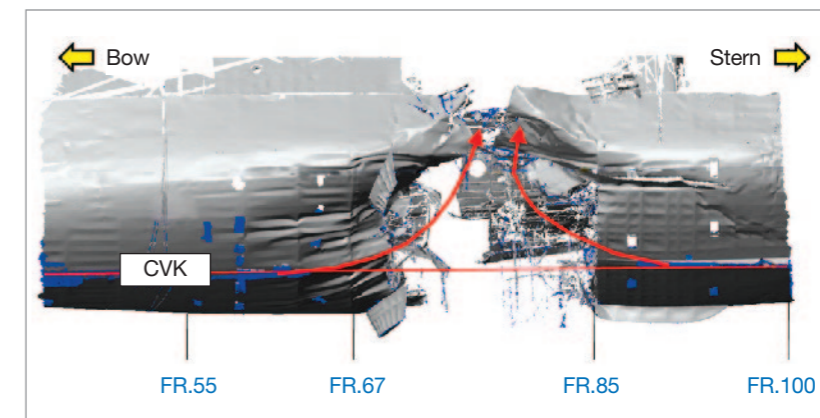
<Figure III-1-9> Fractured surface of portside bottom

The precision analysis on the deformation of the hull, as seen in <Figure III-1-9>, supports the assessment that a non contact underwater explosion occurred below the portside gas turbine room, and the shock force generated migrated to the internal structures on the starboard side to cause the deformation.

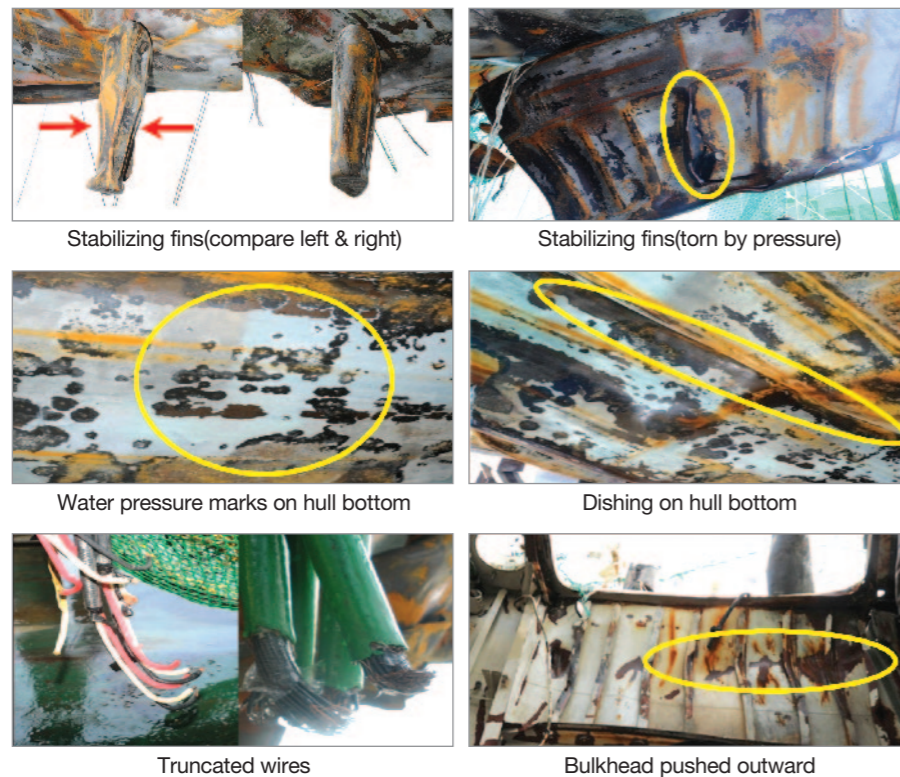
<Figure III-1-10> Trace analysis

As <Figure III-1-10> shows, the portside stabilizing fins were crushed on the bottom portside, and the fin on the starboardside was torn with pressure marks. The bow breakplane's keel on the starboard side hull bottom had marks caused by a strong water pressure and bubble dishing marks on the bow breakplane region, where paint had been scratched off by a strong water pressure. The wires at the breakplane were truncated with a strong force without traces of melting by heat, and the gas turbine room's rear bulkhead stiffeners were pushed toward the upper starboard side, and traces of ripping were also observed.

Such pressure, water pressure, dishing, truncation, cutting, pushing, and ripping traces

were assessed to have been caused by a shockwave and bubble effect from an underwater explosion.

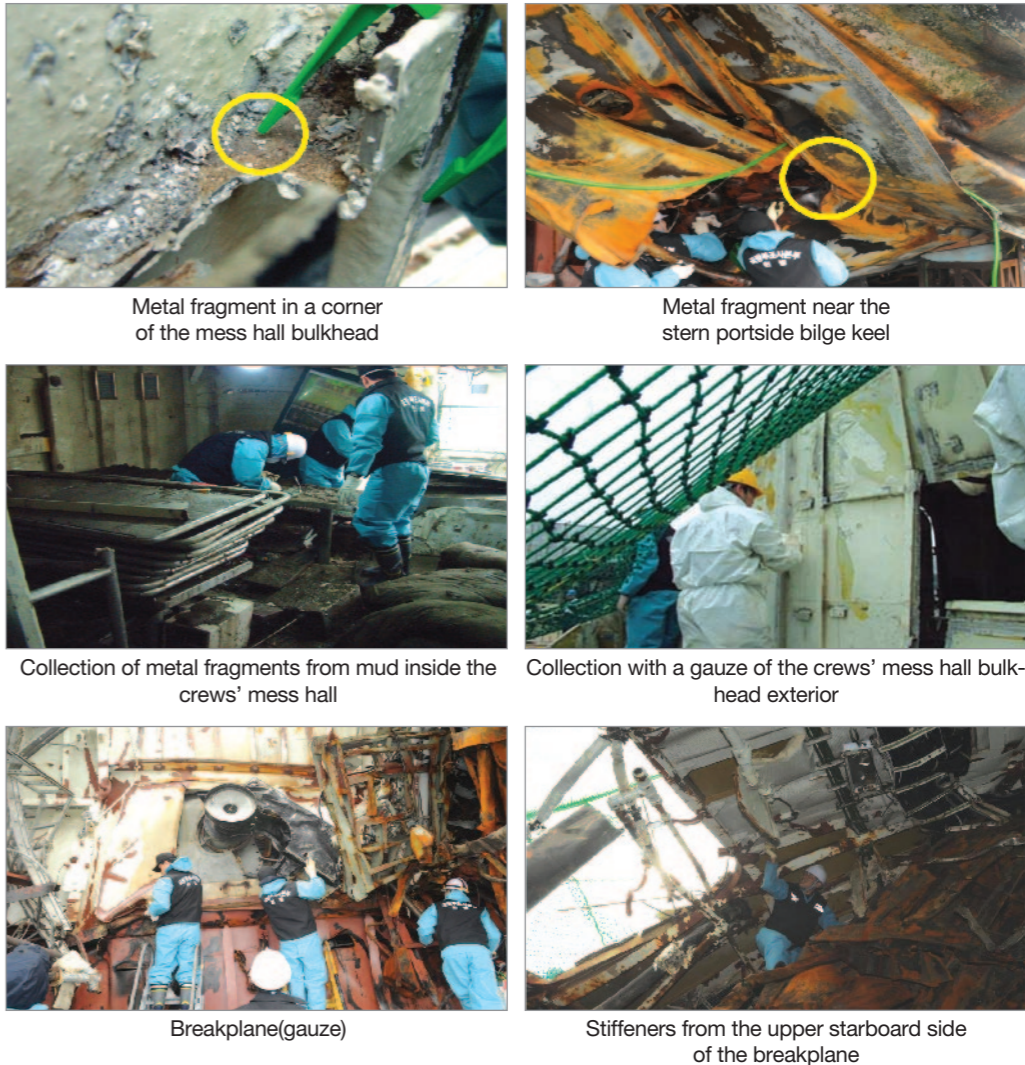
〈Figure III-2-3〉 Evidence collection at the stern

During the stern salvage, from 1430 to 2330 hours on April 15, collection activities using gauze were focused on the breakplane. 11 items such as fibers and insulation material dispersed on the breakplane, and 2kg of mud from the diesel engine room were collected. After moving to the 2nd Fleet Command in Pyeongtaek on April 18, the first precise examination was conducted between 0800~1700 hours. A careful observation was ex-

cuted on the breakplane, along with O-1 deck, and the crews' mess hall(the areas near the breakplane). Asbestos, and fiber were collected from the breakplane, and metal fragments squeezed in fissures or mud were also extracted. 25 bags of mud were also collected from the diesel engine room and crews' mess hall floors(total of 147 items collected). Second precise examination was conducted on April 21 between 0800~1800 hours. During the process, new metal fragments and additional 60 items of evidence were discovered. The team used gauze to wipe the entire breakplane to collect evidence.

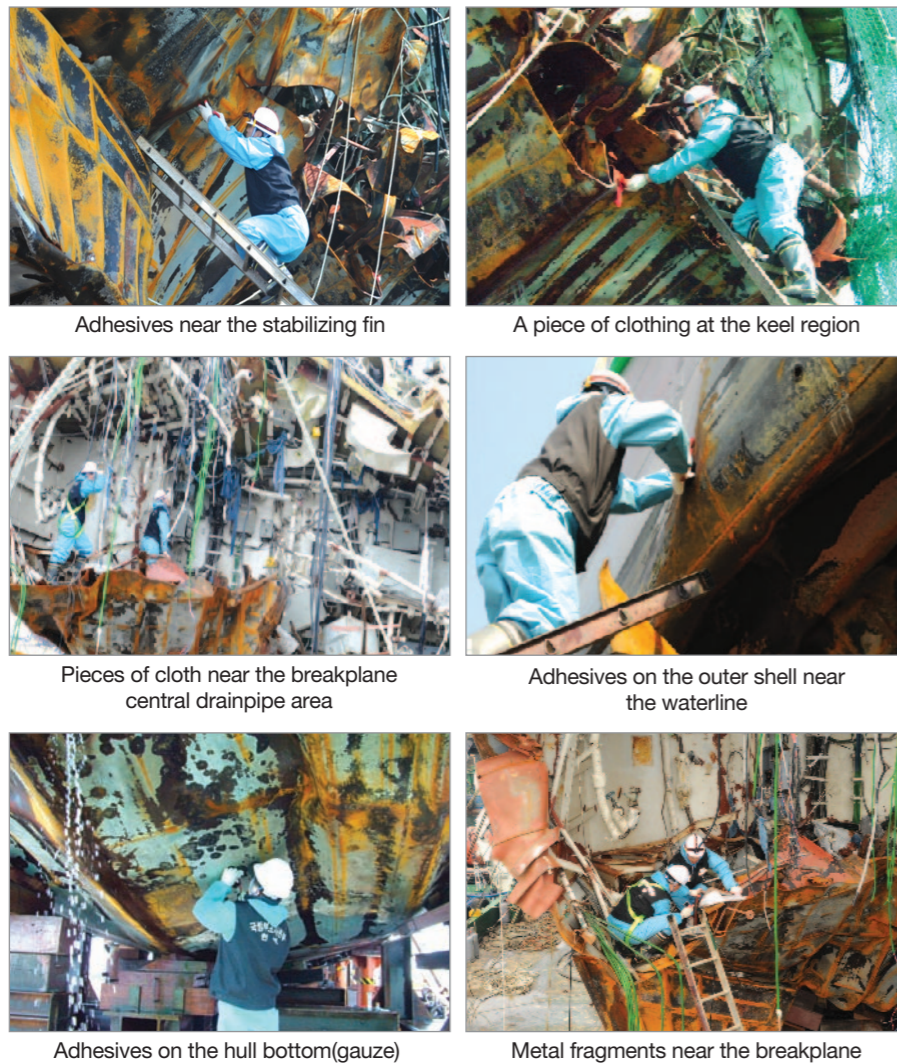
〈Figure III-2-4〉 Evidence collection at the bow

On April 24, when the bow was being salvaged, an on-scene analysis aboard the barge was conducted from 1220~1620 hours. Metal fragments were collected from the bow breakplane starboard side, and gauze was used to wipe and collect foreign substances on the damaged and fractured regions of the hull and stabilizing fins. 46 items such as fibers and heat insulations dispersed on the bow breakplane were collected, including 6 glass fibers and sponges underneath the stack damage area.

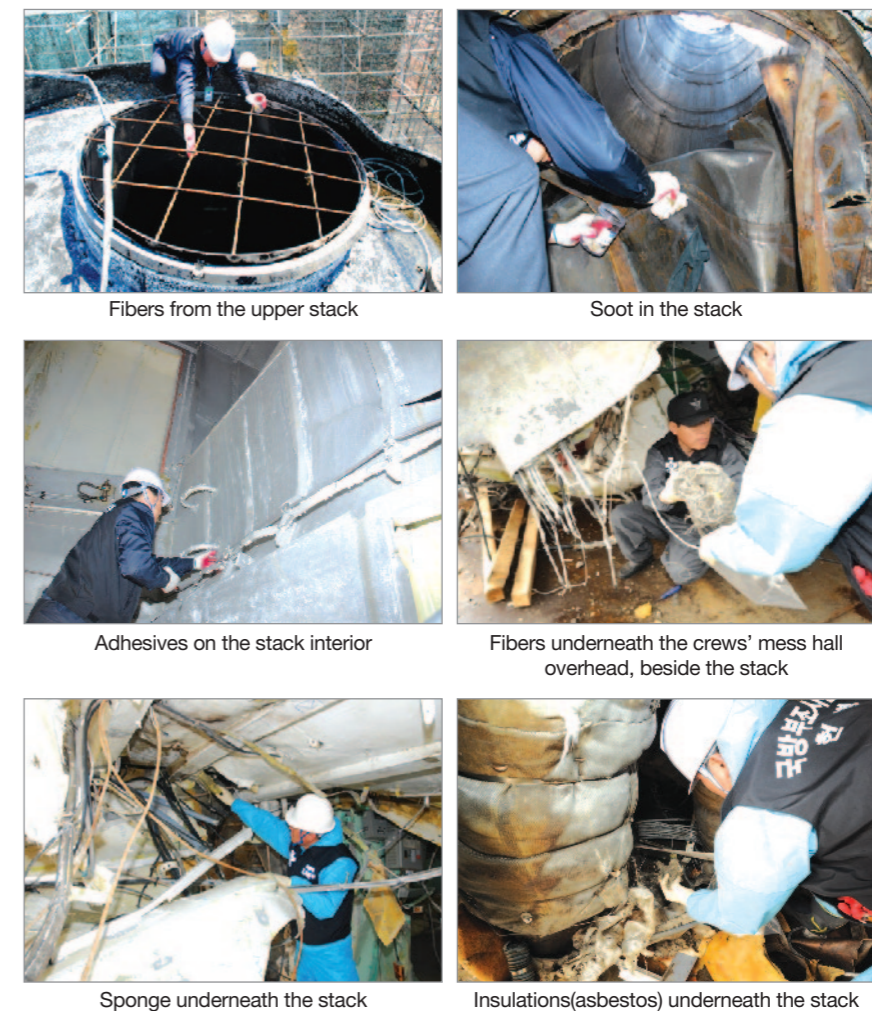
〈Figure III-2-5〉 Evidence collection at the stack

On April 26, after moving the bow and stack to the 2nd Fleet Command in Pyeongtaek, detailed analysis on the bow and stack area was conducted from 0800~1600 hours and metal fragments dispersed around the bow breakplane curvatures were collected. Through wiping with gauze, 33 items including asbestos and sponges on the breakplane, fibers tangled around the central pipelines, asbestos and fibers from the lower stack, and soot samples from the stack interior were also collected. From May 1 to 8, detailed analysis was conducted four times on the stack, and 19 additional items such as white powder from the internal and external surfaces of the stack, sponge, and fiber were collected. Thus, a total of 316 items were collected from the salvaged hull.

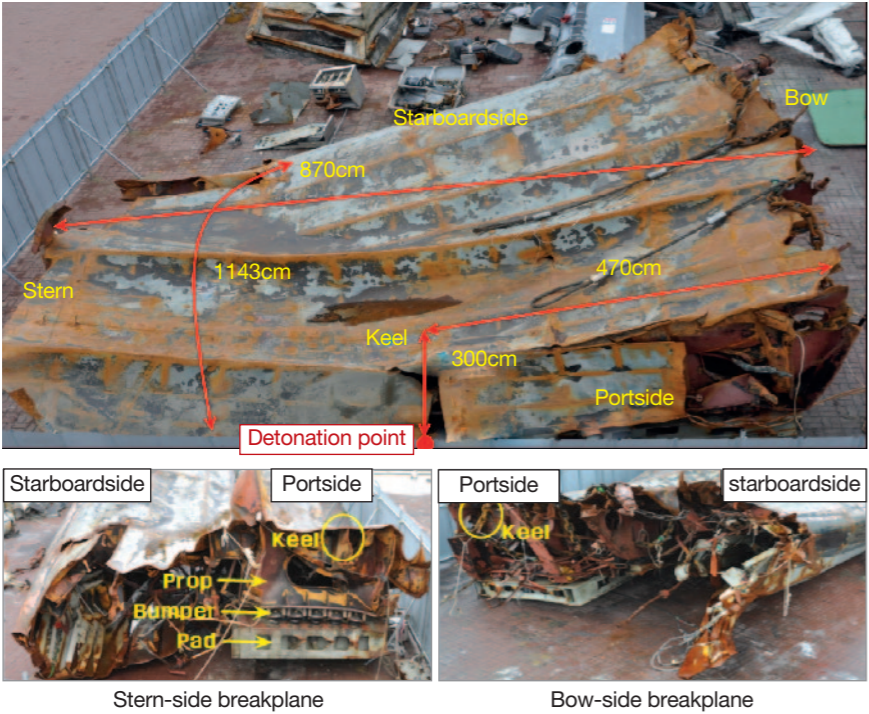
<Figure III-2-9> Salvaged bottom shell portion of gas turbine room

The salvaged gas turbine room was 8.7m in length and 11m in width on the hull bottom and on the starboard side, and weighed about 30tons as shown in <Figure III-2-9>.

The point about 3m away from the gas turbine room’s portside hull bottom, which was expected to be the location of detonation, was damaged. The gas turbine pad, bumper, and props that were formed with a strong steel-frame structure were not severed, but the fore and aft regions of the pad which are relatively vulnerable were severed. 3 pieces of gauze were used to wipe the hull bottom and the breakplane, and 2 metal pieces were collected from the gas turbine room.

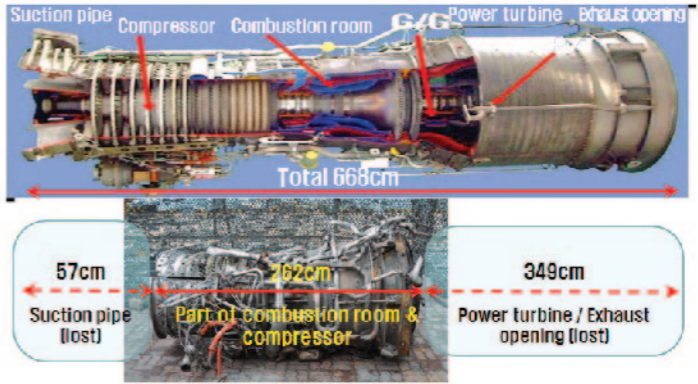
<Figure III-2-10> Salvaged gas turbine

Also, as for the turbo engine(gas turbine) which was salvaged on May 18, the suction pipe(57cm) and the power turbine/exhaust opening(349cm) were missing from the 668cm long body that is consisted of the suction pipe, compressor, combustion room, power turbine, and exhaust opening. The combustion room and the part of the compressor(262cm) were intact. Considering that this equipment is covered by the protective shell, the JIG assessed that metal fragments or explosive components are unlikely to be detected, so the JIG confirmed the deformation of shape without conducting an extra collection search.

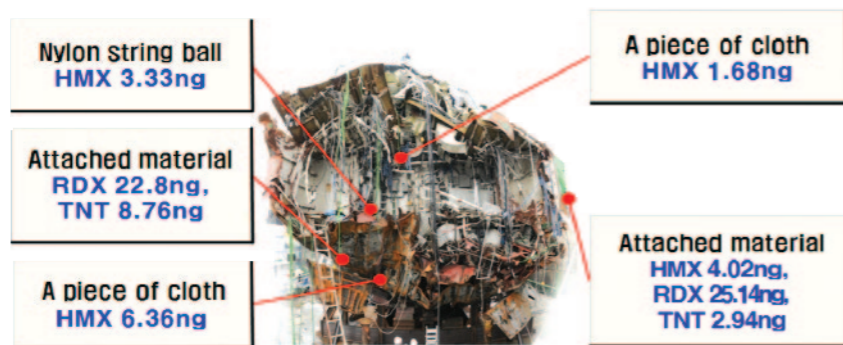
〈Figure III-2-11〉 Detected explosives in bow area

First, HMX was detected on the bow breakplane on items such as the nylon string ball from the 1st platform, attached materials on the shell of the draft line, and cloth near the piper and keel, and the JIG detected RDX, and TNT as well on the attached materials on

the shell of the draft line and stabilizer. In total, 15.39ng of HMX, 47.94ng of RDX, and 11.7ng of TNT were detected on 8 items.

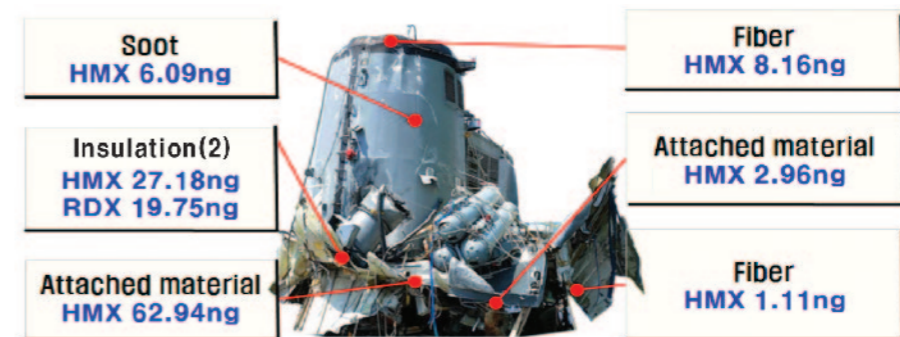
〈Figure III-2-12〉 Detected explosives in stack area

On the stack that was detached due to the explosion pressure, HMX was detected on the internal soot, upper fibers, attached material underneath, attached material inside the pipe, crew galley's overhead bottom fiber, and the lower insulation. RDX was detected on the lower insulation(2 items). In total, 108.44ng of HMX and 19.75 of RDX were detected on 8 different items.

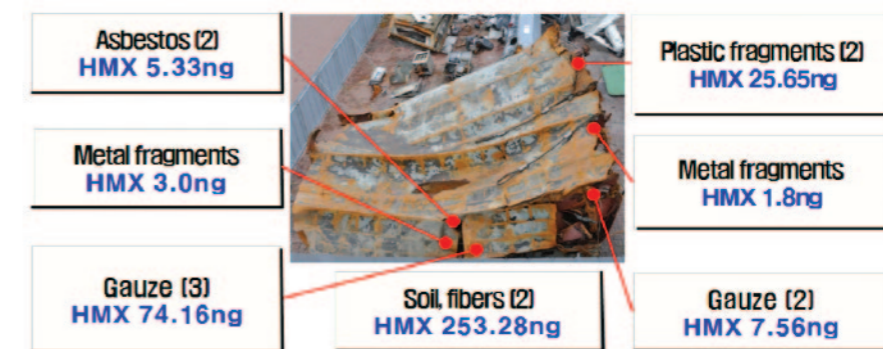
〈Figure III-2-13〉 Detected explosives in gas turbine room

From the gas turbine room, which was damaged and lost from the explosion pressure directly impacting it, a total of 370.78ng of HMX was detected in 13 locations including the inner asbestos portside(2 items), plastic fragments at the protection compartment's ceiling(2 items), metal fragments at the protection compartment, metal fragment on the entrance shell, extracted gauze on the portside entrance shell(3 items), extracted gauze on the breakplane(2 items), and soils/fibers from inside the generator(2 items).

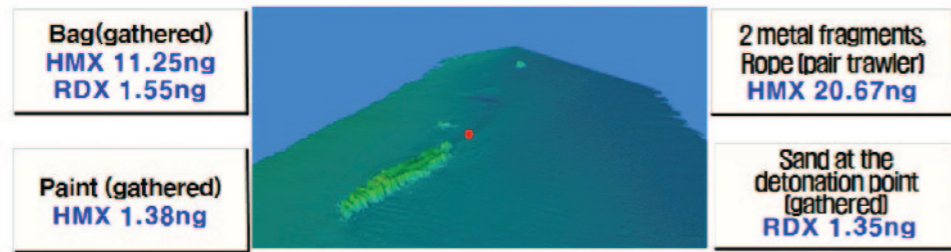
〈Figure III-2-14〉 Detected explosives from seabed evidences

The evidence collection operation of the seabed was conducted with bull trawlers during the search and rescue operation. Amongst the collected items, HMX was detected from the bag, rope, metal(2 items), and paint fragments, and RDX was detected from the bag, and sand around the incident site. In total, 33.3ng of HMX and 2.92ng of RDX were detected from 7 locations.
