Appendix

- I. CCTV Recovery and Analysis Result
- II. Underwater Explosion Phenomenon
- III. Analysis Result on Direction and Location of the Explosion
- IV. Analysis Result on Charge Size and Depth
- V. Analysis Result on Adhered Materials
- VI. Stability Analysis Result
- VII. Basic Hull Strength Analysis Result

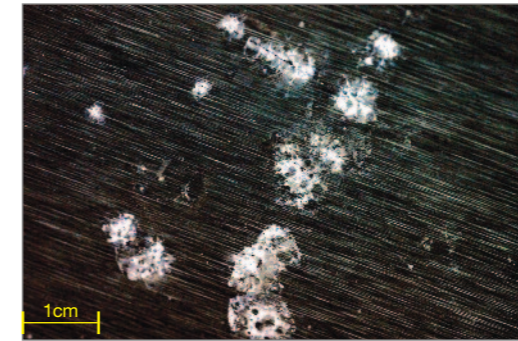
<Figure Appendix II-3-4> White substance obtained from the small-scale UNDEX experiment

In this small-scale underwater explosion test, white substance adsorbed on the alu-

minimum plate was obtained as shown in <Figure Appendix II-3-4>. Through detailed analysis and comparison of the white substance, an important clue for the sinking of ROKS Cheonan was found.

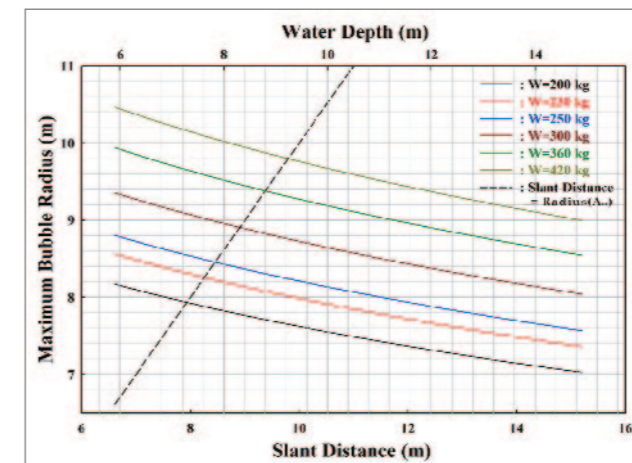
<Figure Appendix II-4-1> Maximum bubble radius vs. slant distance

To determine the type of the weapon system, a depth of the explosion, the TNT equivalent weight of the explosive from surfaces of the salvaged hull, and theoretical and empirical formulas for an underwater explosion were applied. <Figure Appendix II-4-1> summarizes the most plausible explosion conditions chosen under the assumption that bubble jet caused the break. Since the bubble jet is formed only in the presence of a rigid wall near the origin of the explosion, the maximum effect occurs when the maximum bubble radius(A_m) and the slant distance between the keel and the origin are approximately the same. Hence the maximum bubble jet effect is obtained in the range of charge size(200~360kg TNT equivalent) and depth(6~9m) near the dashed line in <Figure Appendix II-4-1>.

For instance, when 250kg of TNT equivalent and 6m depth are applied to the equation (5), which is used for a calculation under the free sea surface environment, the projected value of the maximum height of the water jet is computed as approximately 82m.

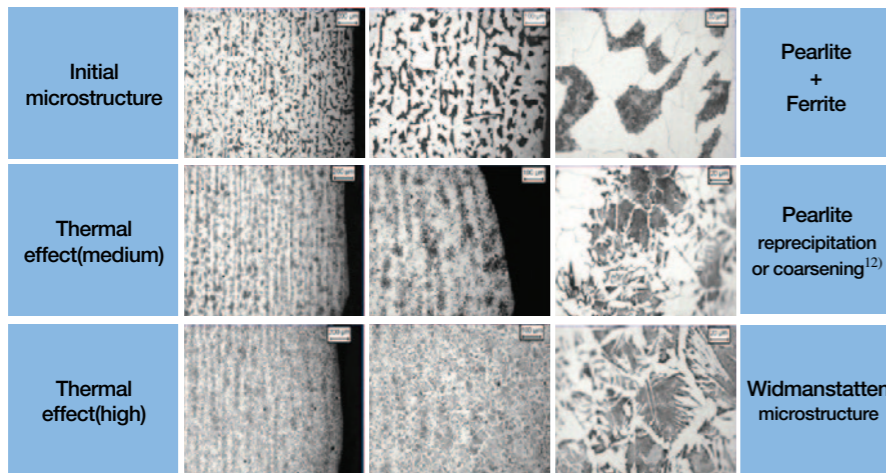
〈Figure Appendix III-3-3〉 Typical microstructure change due to heat influence(example)

For the 200× magnified images, the sample 2 showed the stripes spaced closer and thinned out compared to sample 3 collected from starboard side, and showed typical pearlite + ferrite⁹⁾ microstructure. The black parts were pearlite structure. If there were a heat deformation on the portside, as shown in <Figure Appendix III-3-3>, rolling stripe melting due to pearlite coarsening should be observed; however, since such phenomena were absent on the samples, it was confirmed that there had been no heat over 723℃. This can be a basis in proving the cause as a non-contact external explosion.

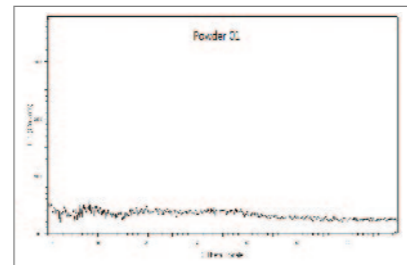
〈Figure Appendix V-1-3〉 X-ray diffraction result

In XRD analysis, X-rays scattered from different atoms within the crystal mutually interfere with each other. If the incident X-ray is monochromatic, the scattered beams for each type of atom interfere to give strong diffraction patterns in a certain direction. The diffraction peak¹⁴⁾ depends on the distance between each lattice in the crystal, i.e. the size of

Normally, the surface of pure aluminum undergoes oxidation in a very short time and becomes a thin layer(several nanometer) of amorphous aluminum oxide. Since this layer is quite dense and oxygen is unable to penetrate this layer, there ought to be no further oxidation inside this layer. However, when the aluminum is exposed to moisture, acids and bases for a long time, it forms white corrosion products. The major components of these white corrosion products are aluminum hydroxide($Al(OH)_3$, bayerite) along with boehmite($AlO(OH)$) and Al_2O_3 , all of which are known to be crystalline, rather than amorphous. On the contrary, the adhered white material found on the stern of ROKS Cheonan is white amorphous oxides of aluminum, which is assessed not to have experienced corrosion in a natural state.

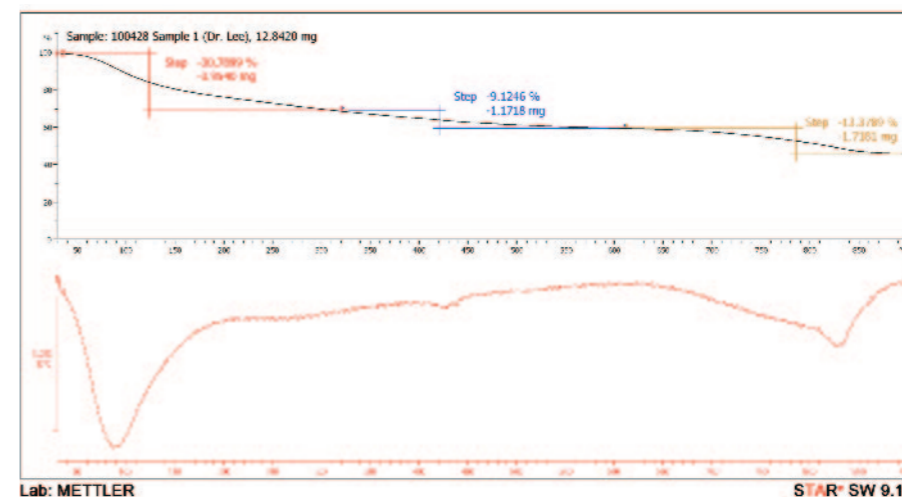
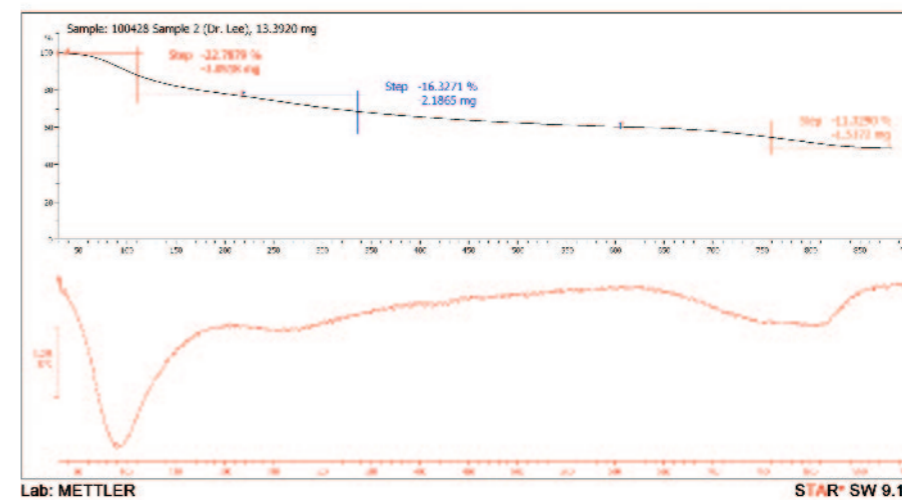
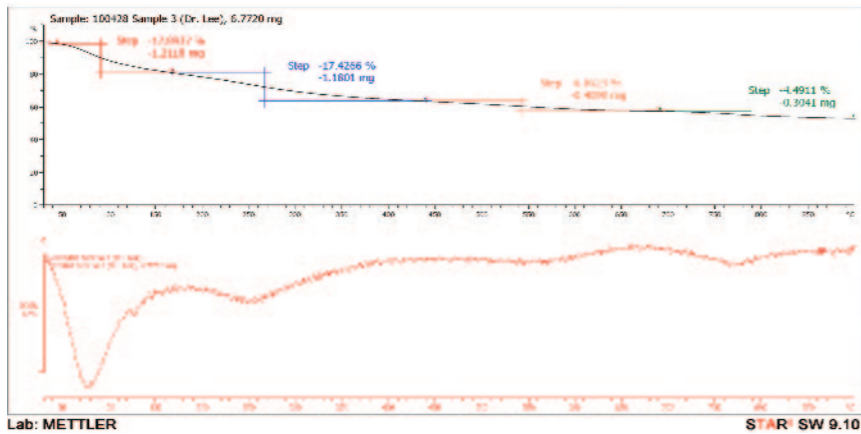
The analysis of TGA pyrolysis for the adsorbed material was performed at temperature range of 30~900℃ and temperature increase rate of 10℃/min. The analysis on sample # 5 could not have been carried out due to shortage in the amount of the sample.

In a temperature range of 30 to 200℃, approximately 20% of the moisture evaporated. Additional 20% of the moisture evaporated slowly between 200℃ and 600℃. Above 600℃, carbon and sulfur components were oxidized and disappeared(See 〈Figure Appendix V-2-5〉). The detailed thermal analysis will be discussed later.

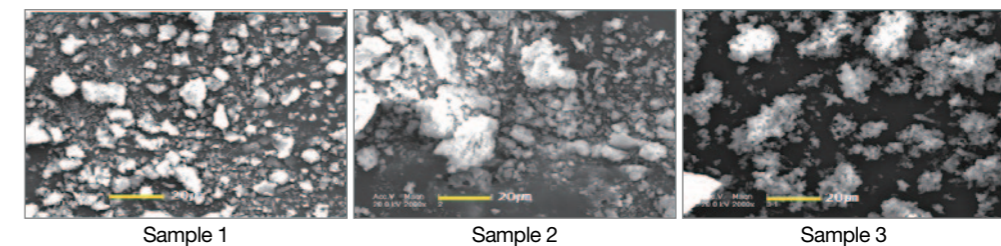
〈Figure Appendix V-3-1〉 SEM images of the adhered material(bow and stack)

The same equipments utilized in the first analysis were employed. The SEM images of this adhered material were similar to those of the stern(See 〈Figure Appendix V-3-1〉).

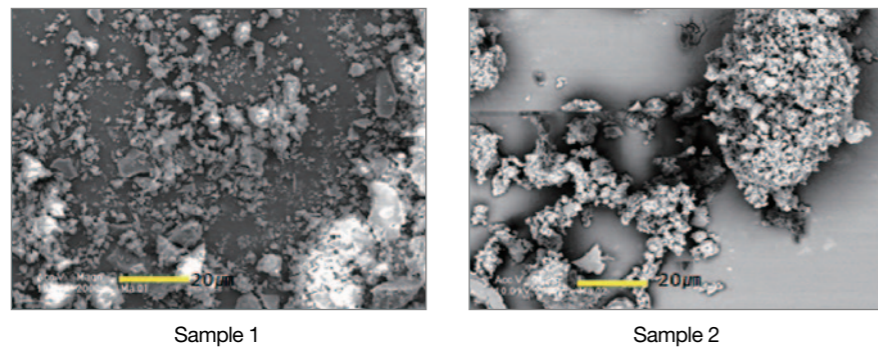
<Figure Appendix V-4-1> SEM images of the adhered material(propulsion section and motor)

After visual examination of the propulsion motor system upon the salvage on May 15, white adhered material was found on the surface of propulsion section and inside the motor. Visually, it appeared to be the same material found in the fractured surfaces of ROKS Cheon-

The analysis utilized the same apparatus used in the first and second analyses except elemental analysis, where the model EA1110 of CE Instruments was used. The SEM images of these two samples of the adhered materials were similar to those of hull samples.

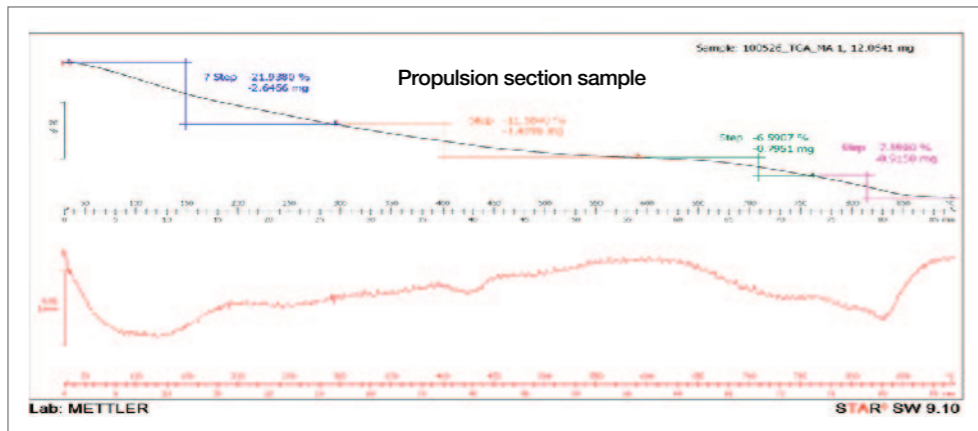
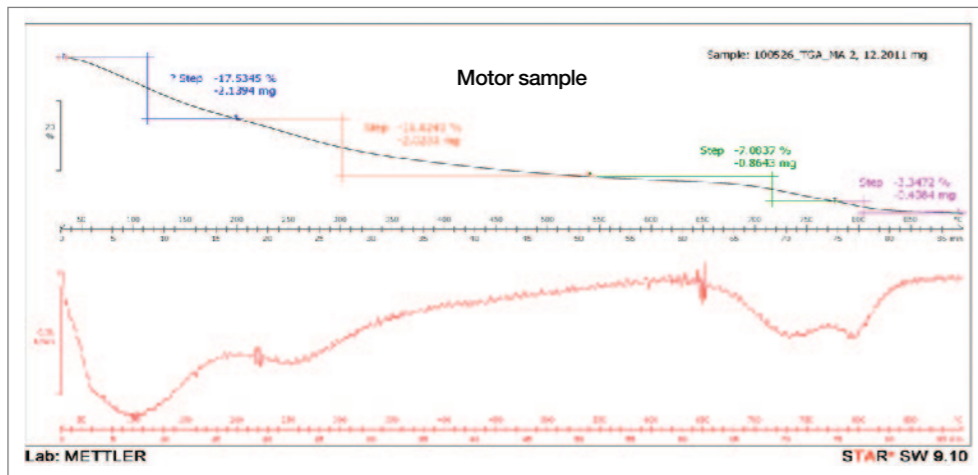
<Figure Appendix V-4-4> TGA results of the adhered material(propulsion section and motor)

The results of CHNS elemental analysis for identifying combustible elements showed that nitrogen was hardly found, and the contents of carbon, hydrogen, and sulfur were 0.40~0.86wt.%, 3.29~3.34wt.%, and 5.60~6.61wt.%, respectively. These results were similar to those of hull samples. In the TGA pyrolysis performed under the same analysis conditions with the hull samples, the results were similar to those of hull samples as well(See <Figure Appendix V-4-4>).

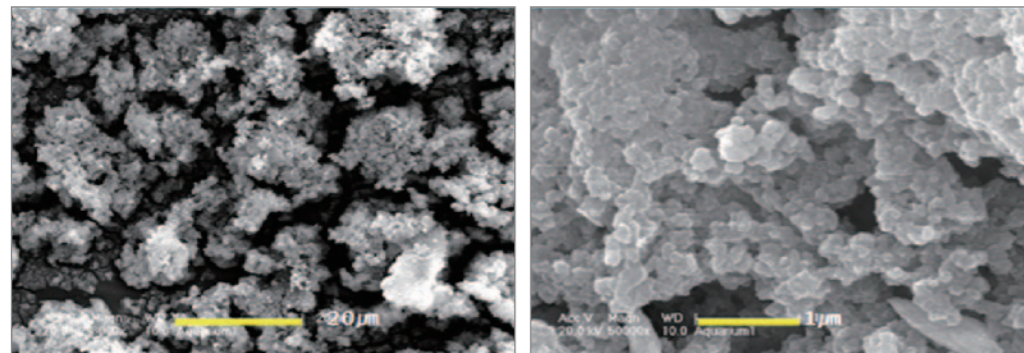
<Figure Appendix V-5-1> SEM images of the explosion products

The adsorbed samples were agglomerates of fine particles. The sizes of the fine particles were less than a micrometer (See <Figure Appendix V-5-1>). According to the EDS results shown in <Figure Appendix V-5-2>, the samples obtained from small-scale UNDEX experiment consisted of carbon, oxygen, sodium, magnesium, aluminum, silicon, sulfur, and chlorine. The results were almost identical to the compositions from the hull and torpedo samples.

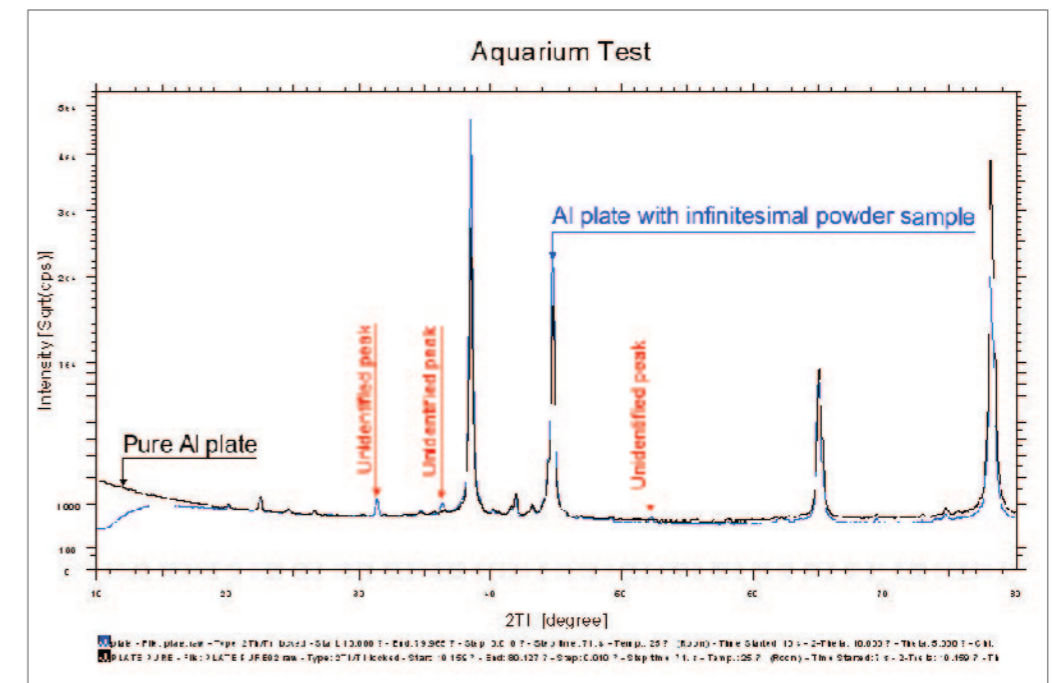
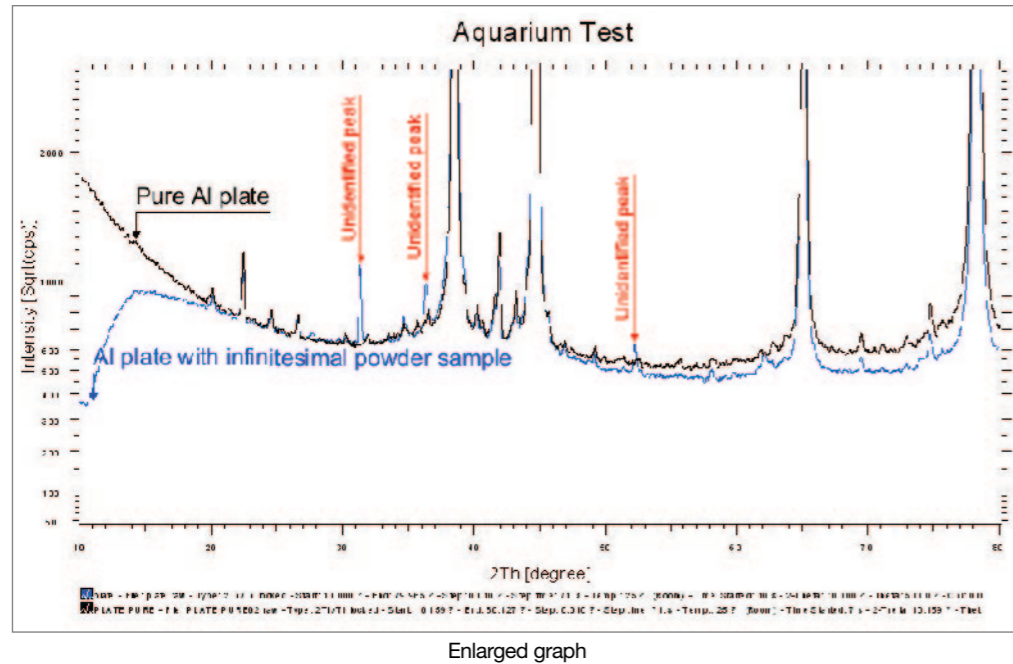
〈Figure Appendix V-5-3〉 XRD results of the explosion products

Since XRD analysis was conducted using the aluminum plate with a small amount of underwater explosion products adsorbed on the surface, the aluminum crystal peak became apparent while the peaks of other substances were relatively weak in comparison. In <Figure Appendix V-5-3>, the XRD result of the explosion products adhered to an aluminum plate was depicted along with the one of the aluminum plate only. When the weak peaks were magnified, crystalline aluminum oxide was rarely observed. This happened because nearly all of the oxides of aluminum were found in amorphous form, which did not appear in the XRD analysis. Other weak peaks were identified to be irrelevant to the aluminum oxide. Through these analysis results, it was found that underwater explosive formulations containing aluminum powder produced amorphous oxides of aluminum upon explosion, as were also found in the hull and torpedo samples. However, the compositions of the explosion products may vary depending on the composition of underwater explosive formulations, amount of explosives, and condition of explosion.

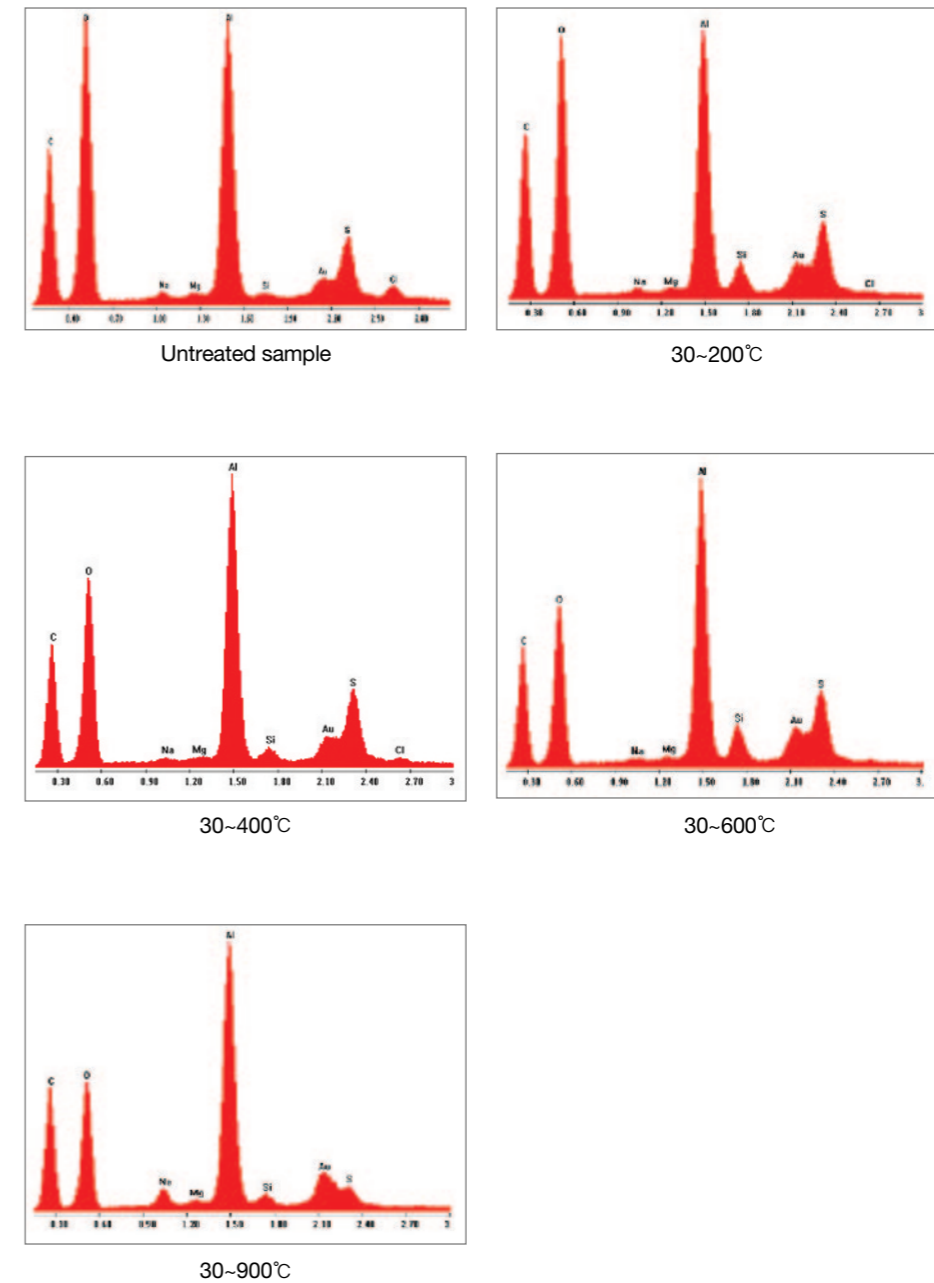
〈Figure Appendix V-6-1〉 Change of elemental composition of adhered materials in EDS area analysis with different heat treatment

The analysis pyrolyzed the adhered material at different temperature ranges (30~200 °C, 30~400 °C, 30~600 °C, 30~900 °C) under nitrogen atmosphere and subsequently performed the EDS analysis with pyrolyzed products in order to comprehend thermal characteristics of the adhered material. The analysis areas for the EDS analysis were 0.25mm × 0.20mm, or 0.50mm × 0.40mm (See 〈Figure Appendix V-6-1〉). In addition, the team also performed a spot analysis with the agglomerate of particles (See 〈Figure Appendix V-6-2〉) and compared with the area analyses. When two different sets of EDS results were compared, the difference of carbon compositions was attributed to the adhesive tape used in the area analysis. Accordingly, the oxygen composition was also changed slightly.

As was shown in two figures, mainly the oxygen content was decreased between 30 and 600°C. Upon further increase of the temperature, carbon and sulfur disappeared.

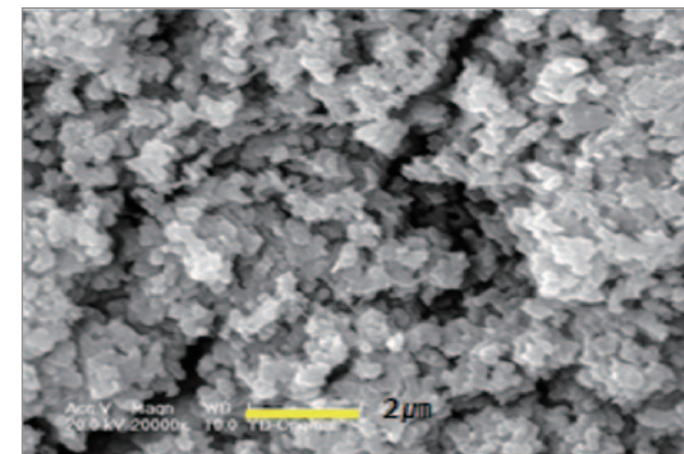
〈Figure Appendix V-6-3〉 Microstructure of the adhered material

This happened due to the evaporation of the moisture in the treatment of samples including vacuum at the EDS analysis of the unpyrolyzed sample. TGA analysis showed that approximately 50% of the moisture evaporated in the temperature range of 30 to 200°C. Further increase of the pyrolysis temperature prompted the oxygen content to diminish due to the evaporation of the moisture entrapped in micro pores (See 〈Figure Appendix V-6-3〉) and/or strongly interacted with the adhered material.

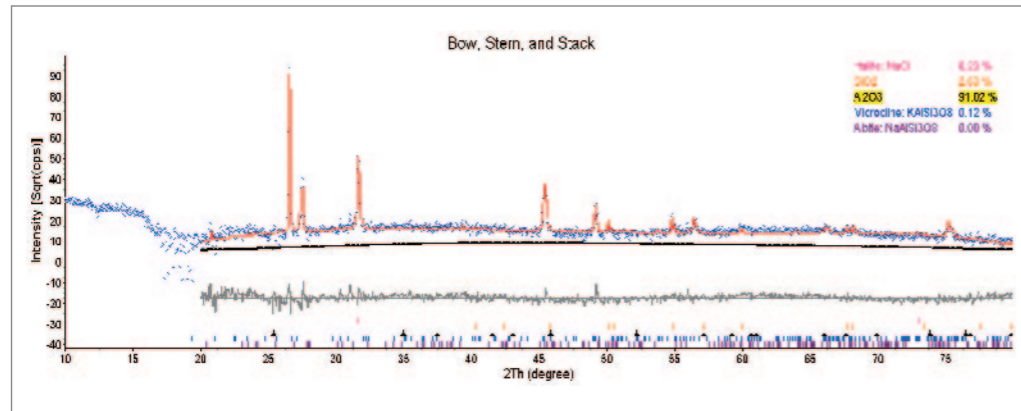
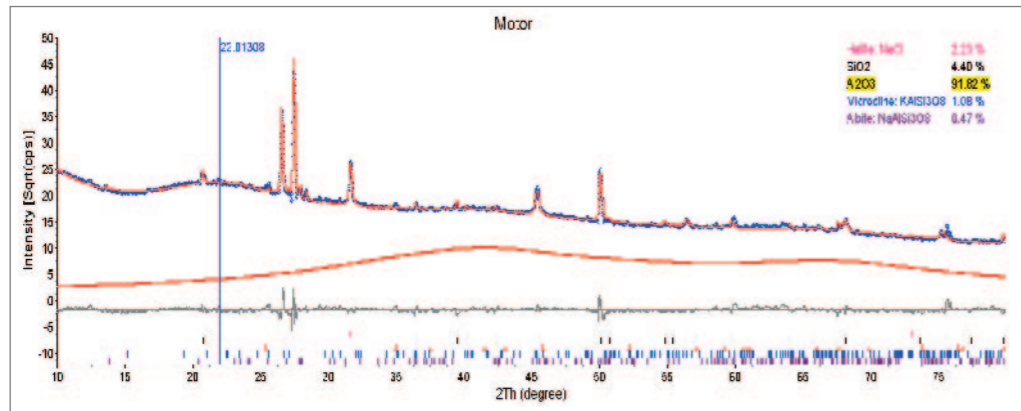
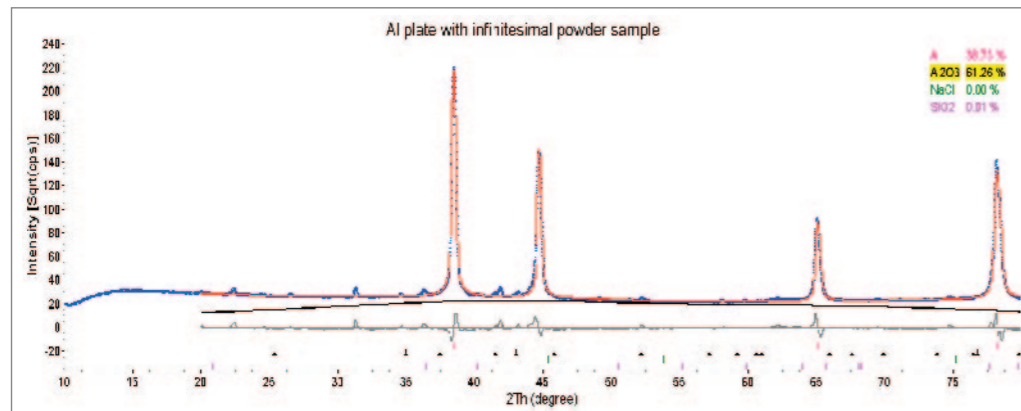
〈Figure Appendix V-7-2〉 Analysis of amorphous Al_2O_3 content

According to the detailed XRD analysis with the TOPAS program, the adhered materials from both the hull of ROKS Cheonan and torpedo propulsion section were composed of more than 90% of amorphous aluminum oxide. In addition, explosion products of UNDEX experiments were also analyzed to have mostly amorphous aluminum oxide, except crystalline ones from the aluminum plate (See <Figure Appendix V-7-2>).

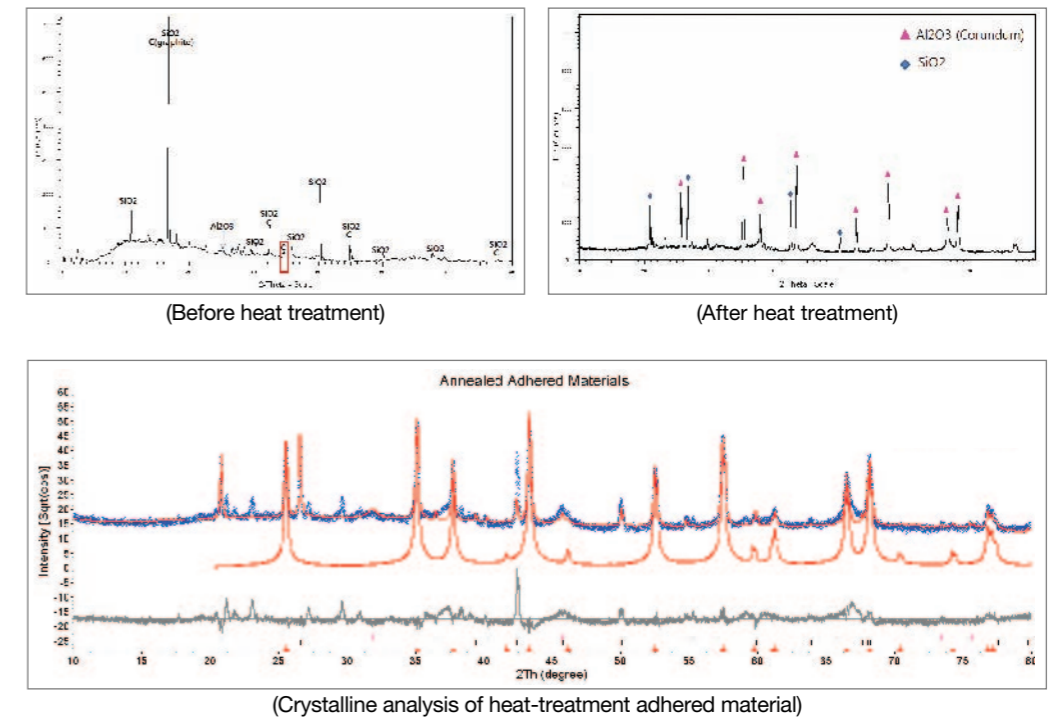
〈Figure Appendix V-7-3〉 XRD results of the adhered material before and after heat treatment

The XRD results depicted in 〈Figure Appendix V-7-3〉 showed that the main component of the adhered material before the heat treatment was silica (including a small amount of graphite), and crystalline aluminum oxide (Al_2O_3) was produced and graphite disappeared after the heat treatment. Thus, the adhered material should be produced by either rapid oxidation or rapid cooling.

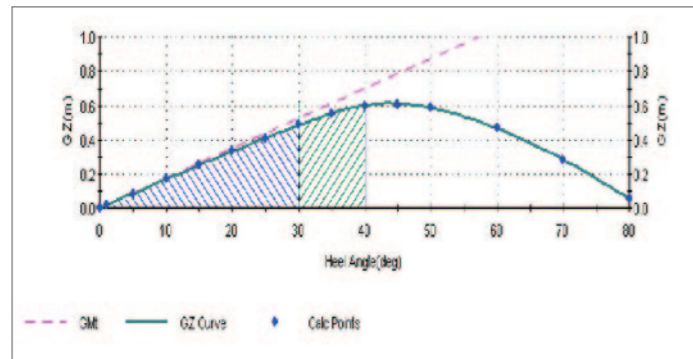
<Figure Appendix VI-3-1> The righting arm curve of ROKS Cheonan prior to the damage

The stability arm curve representing the static stability of ROKS Cheonan is computed as shown in <Figure Appendix VI-3-1>.

A comparison between the static stability of ROKS Cheonan with the standards of UK Navy and merchant vessel is summarized in <Table Appendix VI-3-1>(Note: static stability standard is not established in the US Navy Standard). Through this result, it can be assessed that the static stability level of ROKS Cheonan before the damage was well above than that of a merchant vessel and twice as stable compared to the UK Navy stan-

dard. Prior to the damage, the hull stability was maximized at the heeling angle of 45°, and could endure the heeling angle of up to 80°.

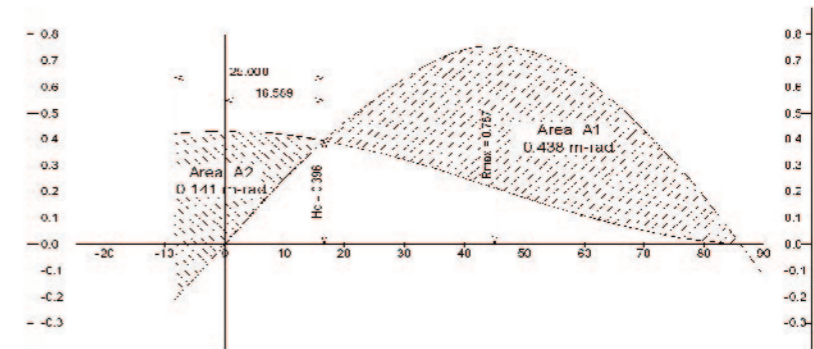
<Figure Appendix VI-3-2> The righting arm curve and the heeling arm curve

The righting arm curve overlapped with the heeling arm curve displaying the dynamic stability of ROKS Cheonan is depicted in <Figure Appendix VI-3-2>.

<Table Appendix VI-3-2> summarizes the dynamic stability of ROKS Cheonan before the damage in comparison with US, UK Navy and merchant vessels. The result indicates that the stability level of ROKS Cheonan prior to the damage was well above the standards for a merchant vessel and was competitive enough in comparison to the US and UK Navy standards.

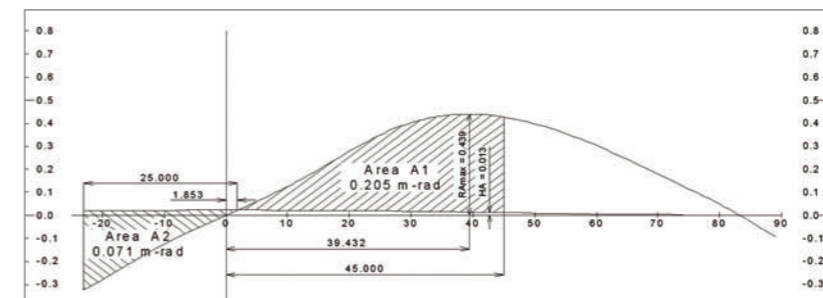
〈Figure Appendix VI-4-2〉 Dynamic stability curve with the damage

As shown in 〈Figure Appendix VI-4-1〉, it is possible to stay afloat with the diesel engine room and gas turbine room flooded. The stability curve for this case is shown in 〈Figure Appendix VI-4-2〉, and the results are summarized in 〈Table Appendix VI-4-2〉. The standards such as initial inclining angle, capsizing force vs. stability ratio(A1/A2), stability(A1), maximum residual righting arm(RA_{max}-HA), and the margin line are all satisfied after the damage. Hence, the stability level with the diesel engine and gas turbine room inundated suffices the standards.

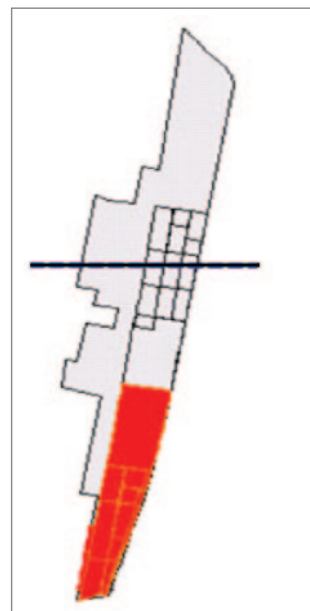
〈Figure Appendix VI-4-7〉 Buoyancy level with four compartments flooded(Case 6)

As one of the cases well beyond the design standard(two compartments flooded), analyses on stability and buoyancy level were conducted with four compartments flooded including the diesel engine room and steering gear room. The stability computation results are summarized in 〈Table Appendix VI-4-7〉. Despite the fact that the initial inclining angle level was satisfied, capsizing force vs. stability ratio(A1/A2), stability(A1), maximum

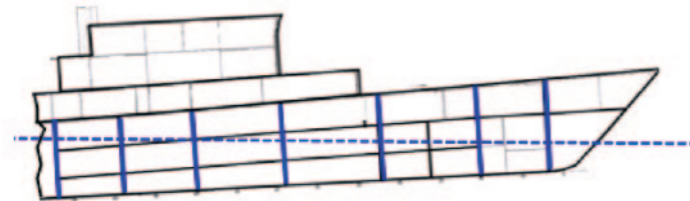
<Figure Appendix VI-5-1> Estimation of the bow buoyancy level immediately after the separation

Right after the separation, the buoyancy level of the bow section before the capsizing is analyzed and displayed in <Figure Appendix VI-5-1>. Since there was no stability on the bow section with the GM value of -0.02m, it is assessed that the ship would have capsized to the starboard direction as the explosion force was exerted from the portside bottom. It is analyzed that the separated bow, having seven compartments, would have experienced gradual flooding. Therefore, it would have been able to maintain buoyancy for some period of time while being capsized; however, due to continued influx of seawater through the entrance and the ventilator, the ship sank eventually.

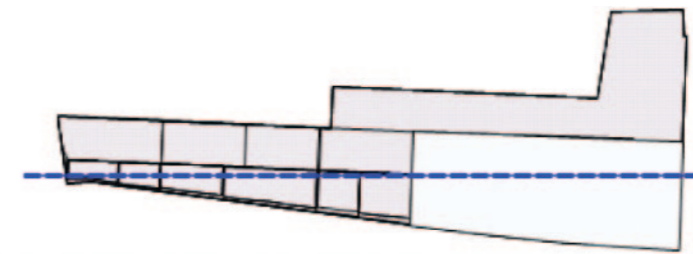
<Figure Appendix VI-5-2> Estimation of the stern buoyancy level immediately after the separation

The buoyancy level of the stern section immediately after the separation is estimated and displayed in <Figure Appendix VI-5-2>. With GM value of 2.35m, it is estimated that its stability was retained with no capsizing.

The separated stern section consisted of four watertight compartments, and especially it contained the diesel engine room occupying 40% of the stern volume; thus, flooding of the diesel engine room would have had a significant impact on the buoyancy

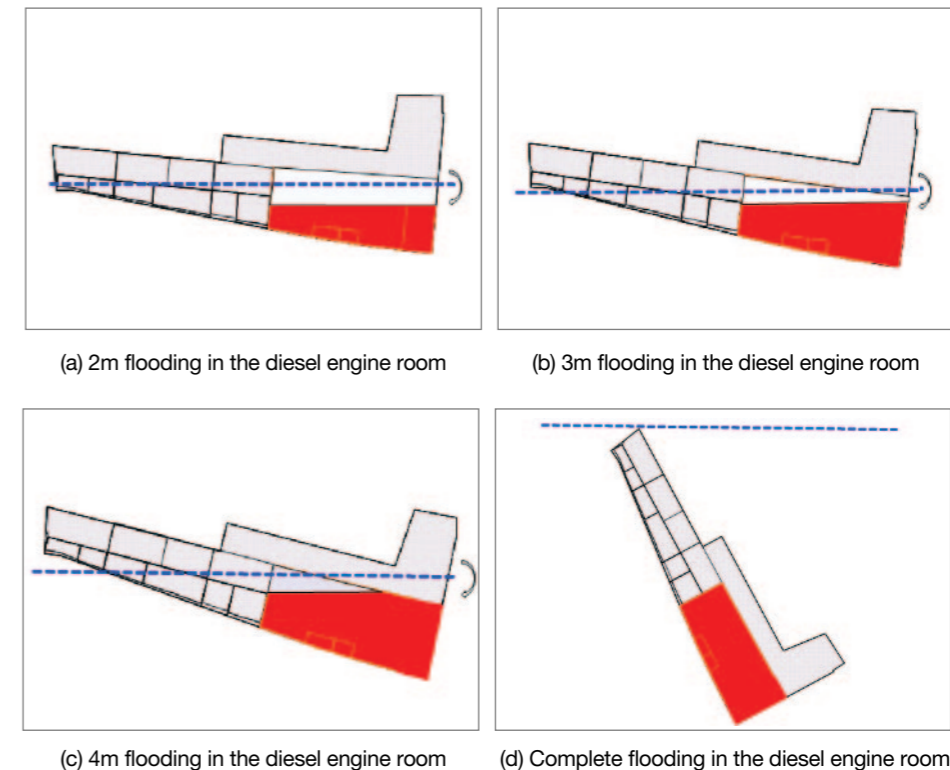
<Figure Appendix VI-5-3> Buoyancy level estimations with each flooding condition in the diesel engine room

level of the stern. First, the posture and buoyancy level of the ship were analyzed in accordance with different flooding conditions in the diesel engine room to substantiate the sinking process of the stern. If compartments other than the damaged diesel engine room were completely sealed, buoyancy retention would have been possible until the damaged diesel engine room was flooded up to 4m, and in case of complete flooding in the diesel engine room, the ship would have sunk. The buoyancy level estimations on each of the conditions are depicted in <Figure Appendix VI-5-3>.

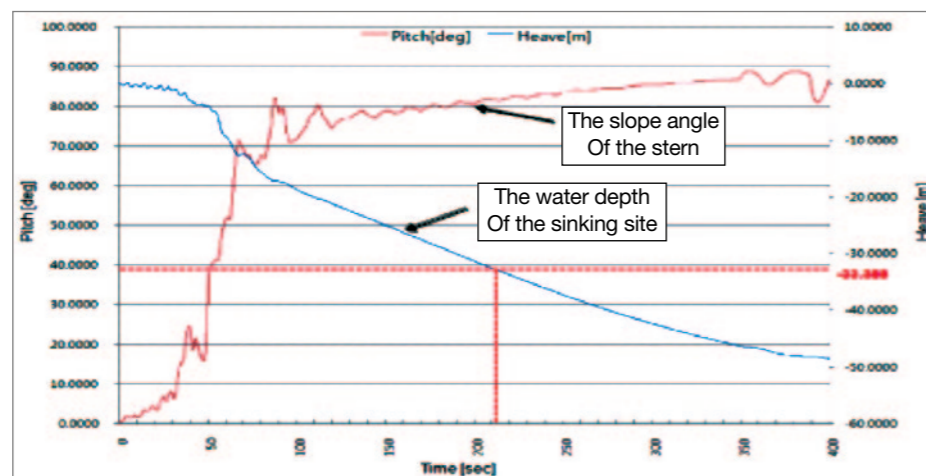
(Figure Appendix VI-5-5) Sinking time estimation of the stern

In regard of the separation centering around the gas turbine room as a center, it is analyzed that the buoyancy level of the stern would have been maintained as long as the bulkhead between the gas turbine room and diesel engine room is not damaged and kept watertight; however, in the actual incident, rapid inflow occurred through the crater on the watertight bulkhead between the diesel engine room and gas turbine room as well as around the stack on the main deck and the upper diesel engine room, leading the ship to sink completely 200 - 250 seconds after the separation.

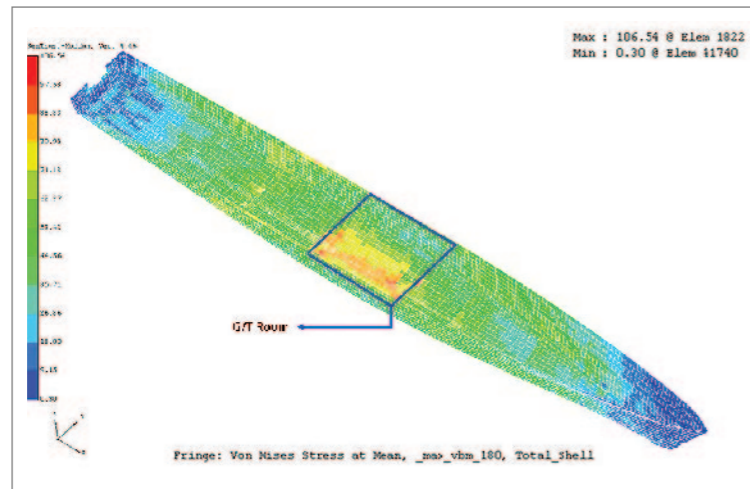
<Figure Appendix VII-4-2> Structural analysis result of the shell plates

vided in <Figure Appendix VII-4-2> and <Figure Appendix VII-4-3>. <Table Appendix VII-4-3> compares the maximum generated stress on the major longitudinal members such as main deck, shell plate as well as the bulkheads, web frames, and the superstructures with the allowable stress. As described in <Table Appendix VII-4-3>, the stress generated on every structural member is below their allowable stress levels. Especially, the stress on the major structural members is, at maximum, around 50% of the standard values, well sufficing the yield strength assessment standard.

Members	Material	Allowable stress(MPa)	Possible maximum stress(MPa)	Remarks
O-2 Deck	AL ²¹⁾	127	20.0	16% Sufficient
O-1 Deck	AL	127	77.6	61% Sufficient
Main deck	MS ²²⁾	200	103.62	52% Sufficient
1st Platform deck	MS	200	42.14	21% Sufficient
2nd Platform deck	MS	200	44.84	22% Sufficient
Shell	MS	200	106.54	53% Sufficient
FR. 39 BHD	MS	177	52.8	30% Sufficient
FR. 77 Web frame	MS	177	152	86% Sufficient

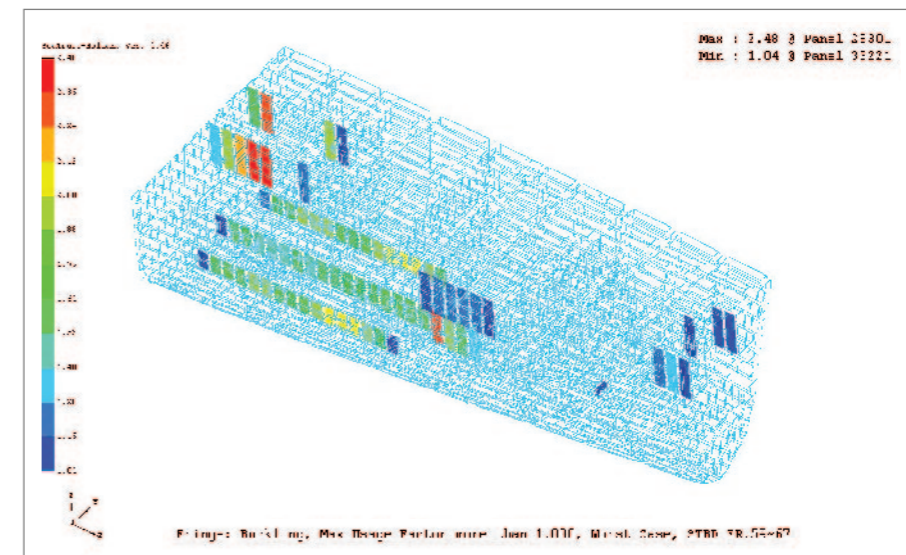
<Figure Appendix VII-4-4> Buckling strength assessment result: FR. 27 ~ FR. 67

For the buckling strength assessment of ROKS Cheonan, an analysis method based on the ship design/construction standard(steel) was applied. The representative buckling strength assessment results on the compressive stress and the breaking stress affecting plates of major structural members(derived by using stress estimates from hull structure analysis) are listed in <Figure Appendix VII-4-4>, <Figure Appendix VII-4-5> and <Figure Appendix

Based on the result of the direct strength analysis regarding the maximum design waves (wave height 10.6m), with extreme loads on the hull, and during the ship lifetime of 25-30 years, it was found that ROKS Cheonan sufficiently satisfies the yield strength standard. Although there is a possibility of buckling in some bulkheads on the stern and the bow, these partial bulkheads are sectioning members, and hence would not affect the hull girder strength as non-resistant bulkheads. Therefore, excluding the possibility of extraordinary conditions such as an external attack, it is analyzed that ROKS Cheonan possessed sufficient structural strength.
